ACCIDENT INVESTIGATION COORDINATING COMMITTEE

**ACCIDENT REPORT ON
8Q-TMK (TWIN OTTER)
At the Ibrahim Nasir International Airport, Water Runway,
Maldives
On 2nd August 2013**

Operator: Trans Maldivian Airways
Manufacturer: Viking Air (Canadian)
Model: DHC-6-300 (Floatplane)

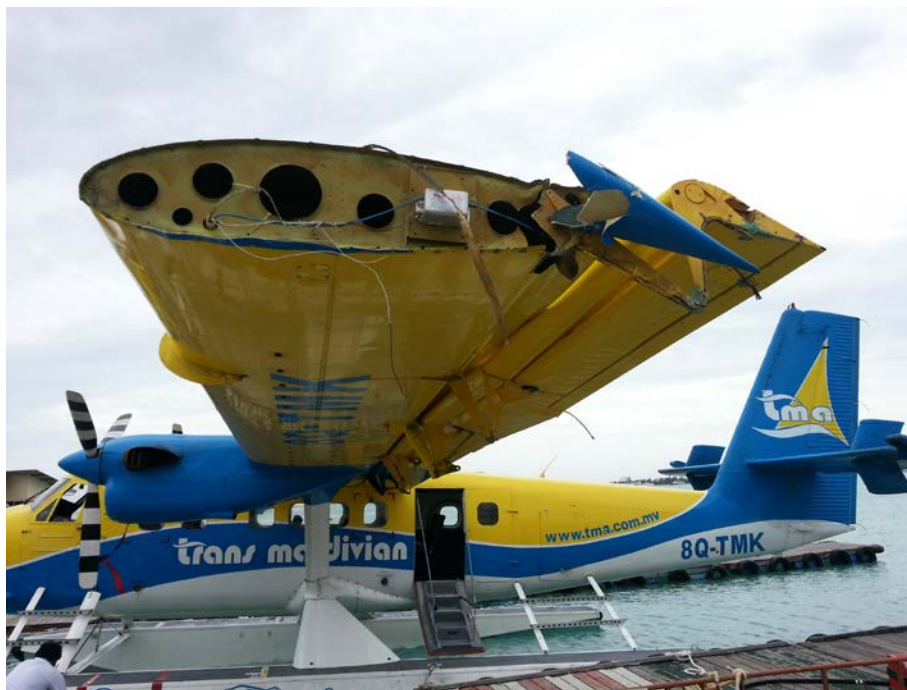
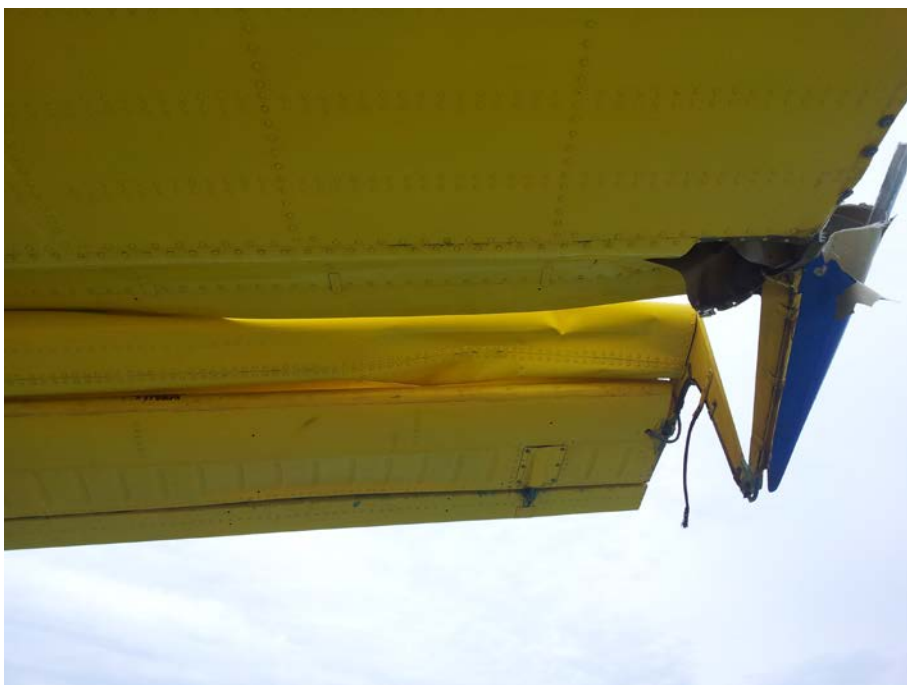
Left Wing

During the initial assessment the following parts were found with major damages: (Appendix 1)
(Refer to MCAR 21.A.435)

1. LH Wing Tip
2. LH Aileron
3. LH out board fore-flap.

The physical evidence and the CCTV footage showed that the wing tip dug into the water on landing. The CCTV footage also shows that the aircraft started to roll to the left side as it was approaching to land. At the time of landing, the left wing tip could be seen digging into water with a splash then the left float touched down and the aircraft turning rapidly to the left. The aircraft turned 90 degrees abruptly with the inertia of the left wing and the aircraft rolled back to normal position and stabilised.

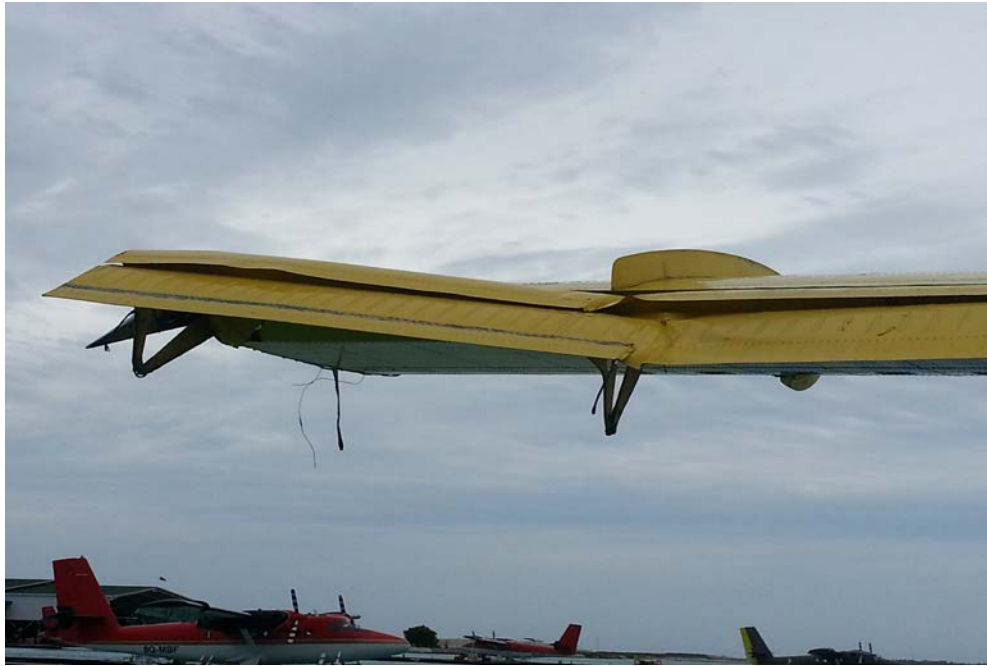
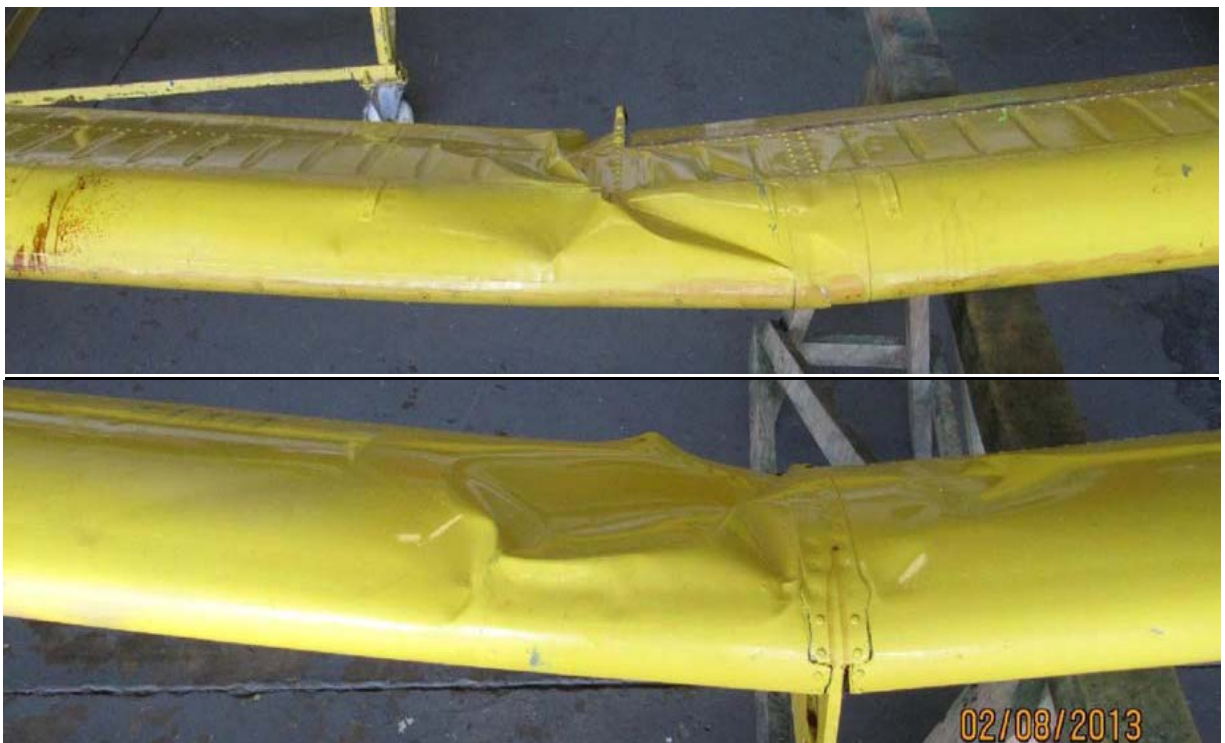
Left Aileron and Fore Flap

The aircraft was taxied to the dock where detailed examination of the damages was carried out by the TMA engineering team. The left wing tip, left aileron and left out board fore-flap of the aircraft were found damaged.
