ACCIDENT INVESTIGATION COORDINATING COMMITTEE

AIRCRAFT ACCIDENT REPORT 2020/03

FINAL REPORT

**THE ACCIDENT INVOLVING VIKING AIR
DHC-6-300, 8Q-TMF, FLOATPLANE
AT VELANA INTERNATIONAL AIRPORT, MALDIVES
on
05 October 2020**

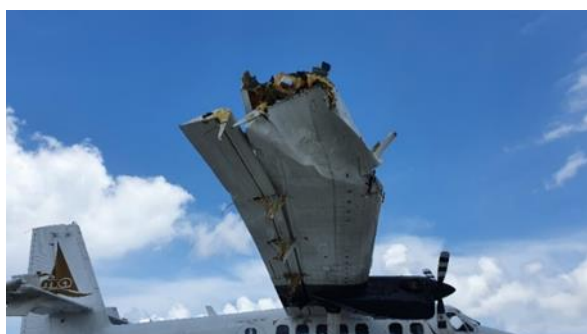
Figure1: RH Wing

1. RH Wing:
 - a. Various damages in the area between ribs 25 to 28;
 - b. The leading-edge bottom skin towards the wingtip buckled upwards;
 - c. Wing tip severely crushed and material missing;
 - d. Wing fin dislocated with the leading edge shifted outboard;
 - e. The inboard trailing flap skin buckled upward.
2. LH Wing:
 - a. Leading edge bottom skin buckled upwards
3. LH Propeller:
 - a. LH propeller blades (all three of them) bent aft;
 - b. LH propeller assembly dislocated.
4. Airframe:

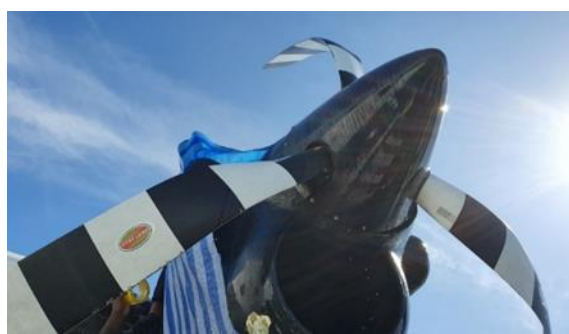
Figure 2: LH Propeller

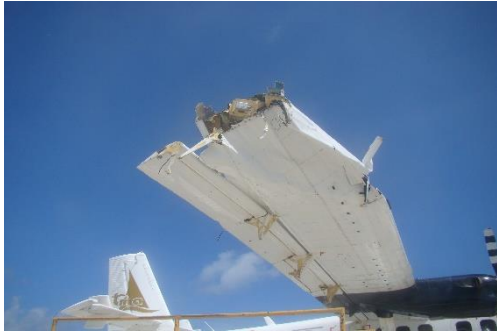
Figure 3: RH Wing: Damage to RH Wing

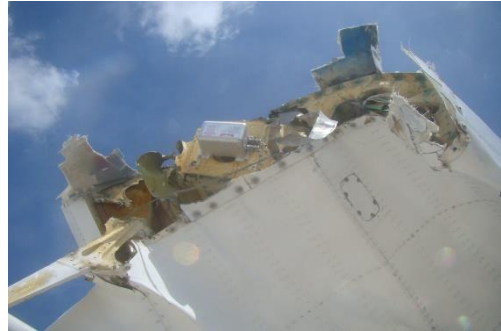
Figure 4: Damage to RH wing tip

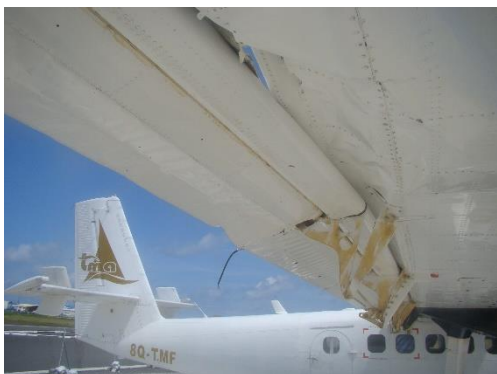
Figure 5: RH Wing: Damage to RH Aileron

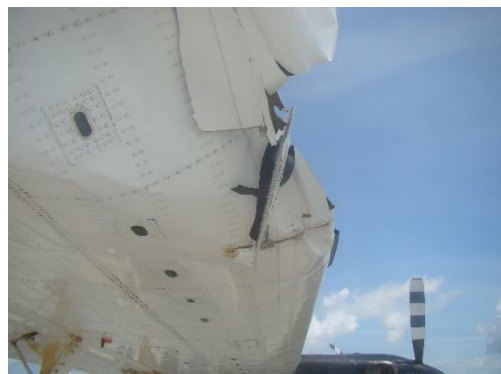
Figure 6: RH Wing: Damage to Wing Leading Edge

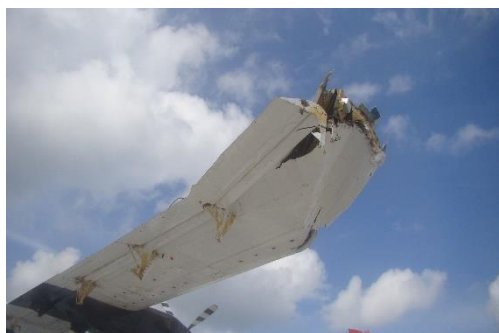
Figure 7: RH Wing: Damage to RH Wing

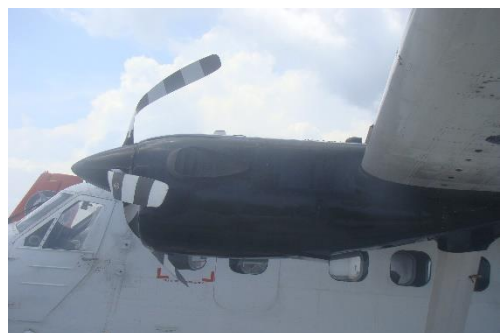
Figure 8: Damaged LH Propeller

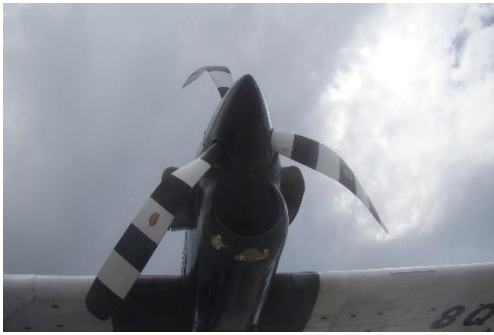
Figure 9: Damaged LH Propeller

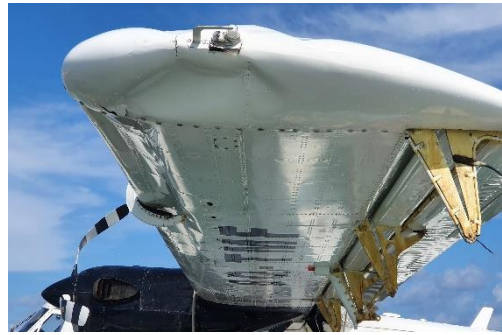
Figure 10: Damaged LH Wing tip
