AIRCRAFT ACCIDENT REPORT P2020/04

PRELIMINARY REPORT

**ON INVESTIGATION OF THE ACCIDENT INVOLVING VIKING AIR
DHC-6-300, 8Q-TMR AIRCRAFT
AT SUN SIYAM IRU FUSHI RESORT WATER AERODROME, MALDIVES**

on 22 October 2020

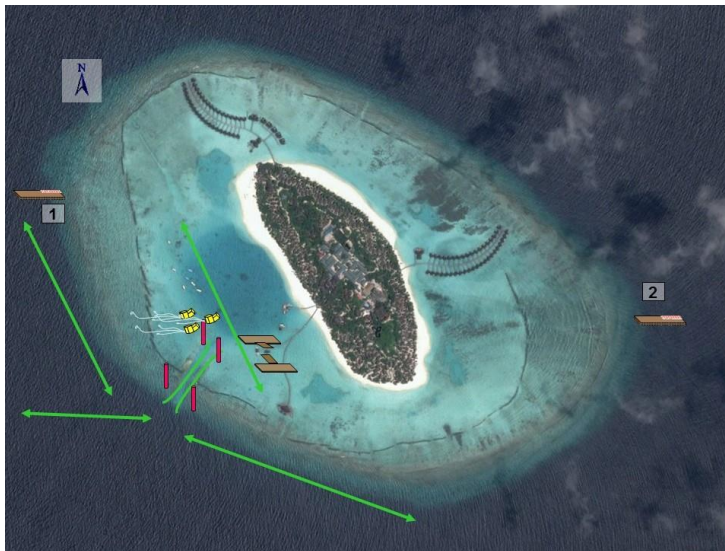
Figure 1: Sun Siyam Iru Fushi Resort Water Aerodrome Chart

Location of the water aerodrome, including 4 water runways available at Sun Siyam Iru Fushi Resort is shown on the aerodrome chart, published by TMA
