**AIRCRAFT SERIOUS INCIDENT REPORT 2020/04**

**FINAL REPORT**

**INVESTIGATION OF THE SERIOUS INCIDENT INVOLVING  
TRANS MALDIVIAN AIRWAYS OPERATED  
VIKING AIR DHC-6-300, 8Q-TMR, FLOATPLANE  
AT SUN SIYAM IRUFUSHI RESORT WATER AERODROME, MALDIVES**

**22 October 2020**

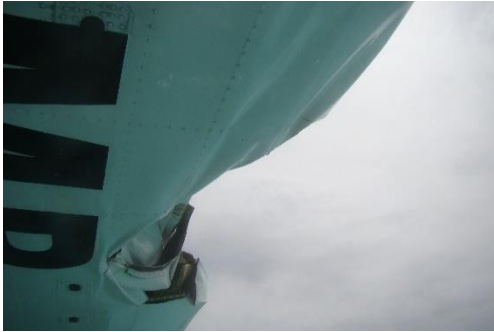
1. LH wing:
  - a. Leading edge dented and skin torn at approximately 63 inches from outboard of STA 60;
  - b. Wing fence damaged;
  - c. On bottom wing skin 3 stringers bent inwards along with the skin;
  - d. On top wing surface skin and 4 ribs damaged
2. LH propeller:
  - a. Approximately 12 inches missing from each of the 4 propeller blade tips;
  - b. Erosion strips de-bonded;
  - c. Blades cracked.

Figure 3: LH Wing: Damage to LH Wing

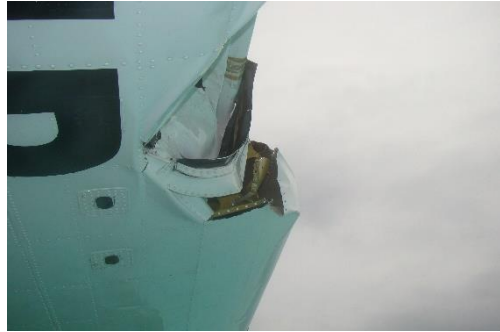
Figure 4: Damage to LH wing

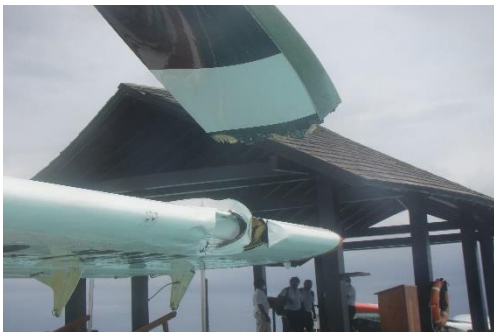
Figure 5: LH Wing: Damage to LH Wing

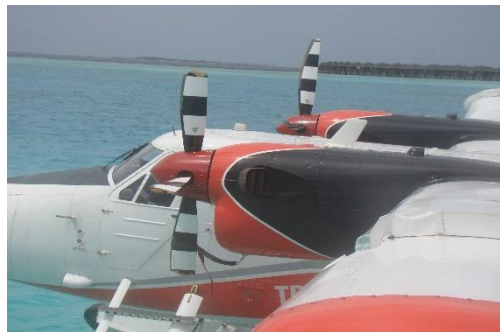
Figure 6: LH Wing: Damage and propeller damage

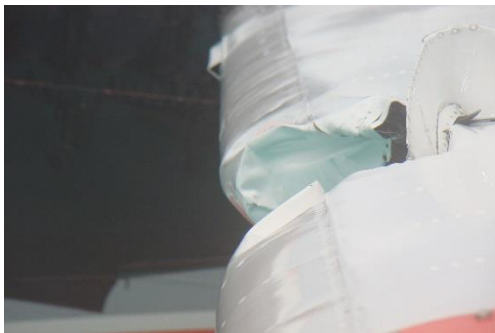
Figure 7: LH Wing: Damage to LH Wing

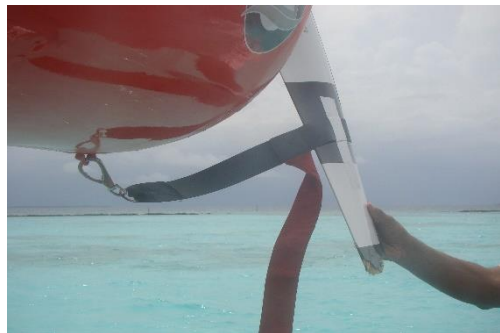
Figure 8: LH Propeller damaged

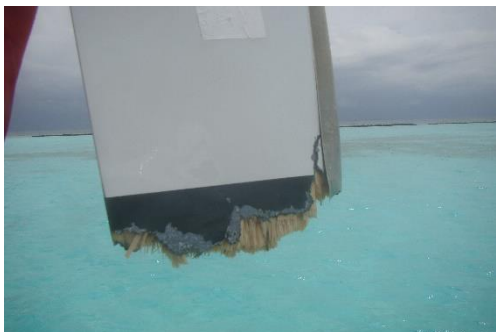
Figure 9: LH Propeller damaged

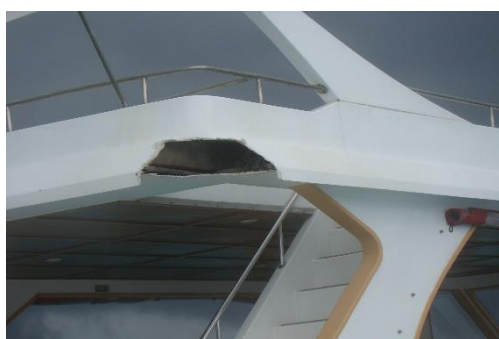
As a result of the collision, scratch marks were found on the aft left-hand corner of the vessel's housing, by the aircraft wing, and the left propeller cut the aft right corner of housing of the vessel. At the time of the incident no person was on board the vessel.

Figure 11: Damage on the vessel

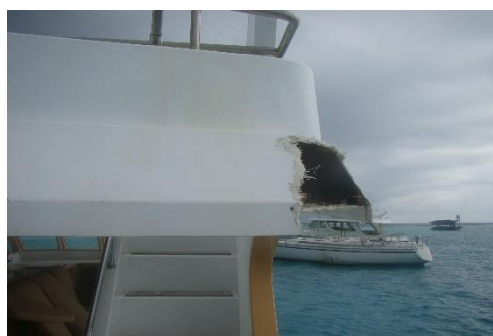
Figure 12: Damage on the vessel

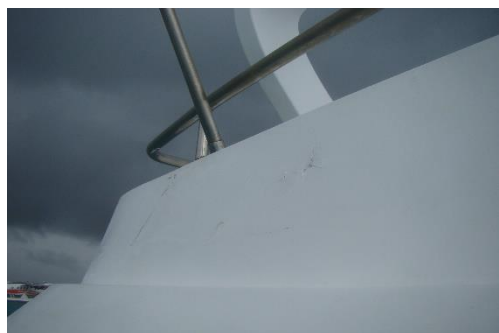
Figure 13: Damage on the vessel
