ACCIDENT INVESTIGATION COORDINATING COMMITTEE

AIRCRAFT ACCIDENT REPORT 2020/02

**PRELIMINARY REPORT ON INVESTIGATION OF THE
SERIOUS INCIDENT INVOLVING CESSNA 172 RG AIRCRAFT, 8Q-GAD, OPERATED BY
ASIAN AVIATION ACADEMY
AT GAN INTERNATIONAL AIRPORT, MALDIVES,
ON 04 JANUARY 2020**

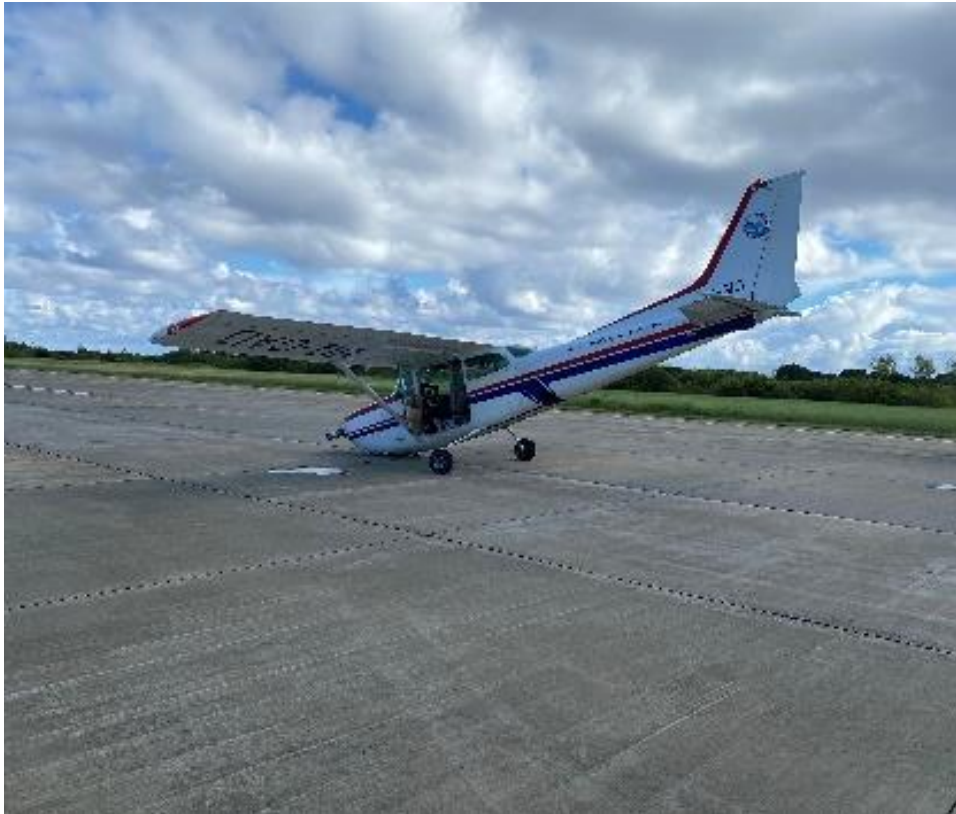
Figure 1: Aircraft on runway

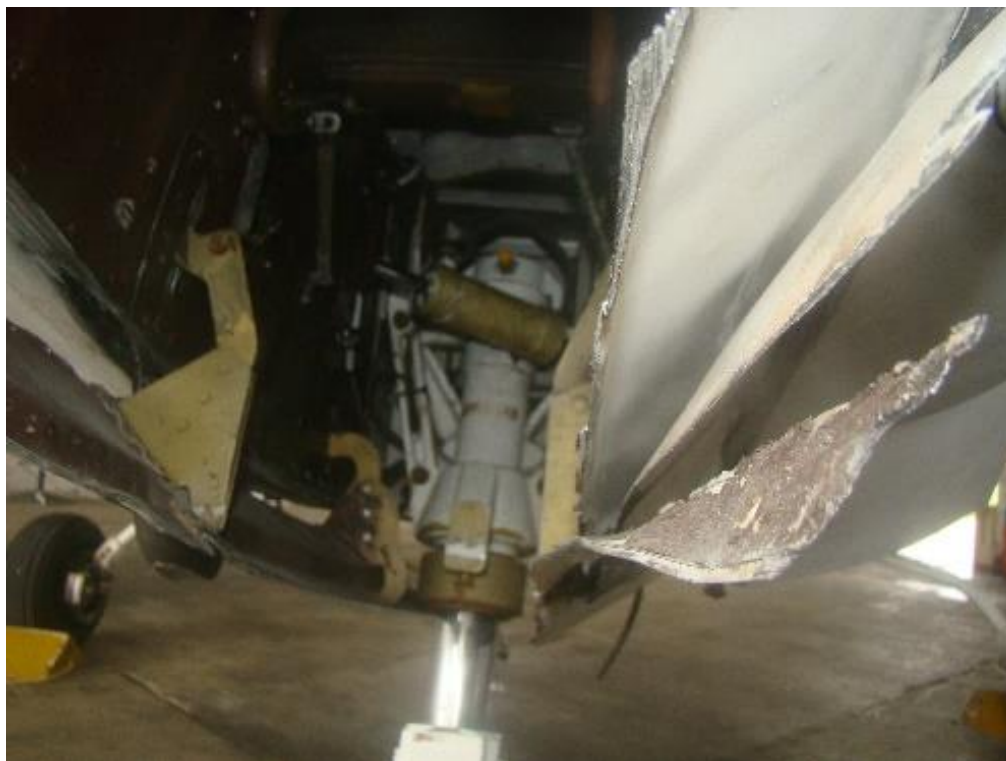
Figure 2: NLG wheel well

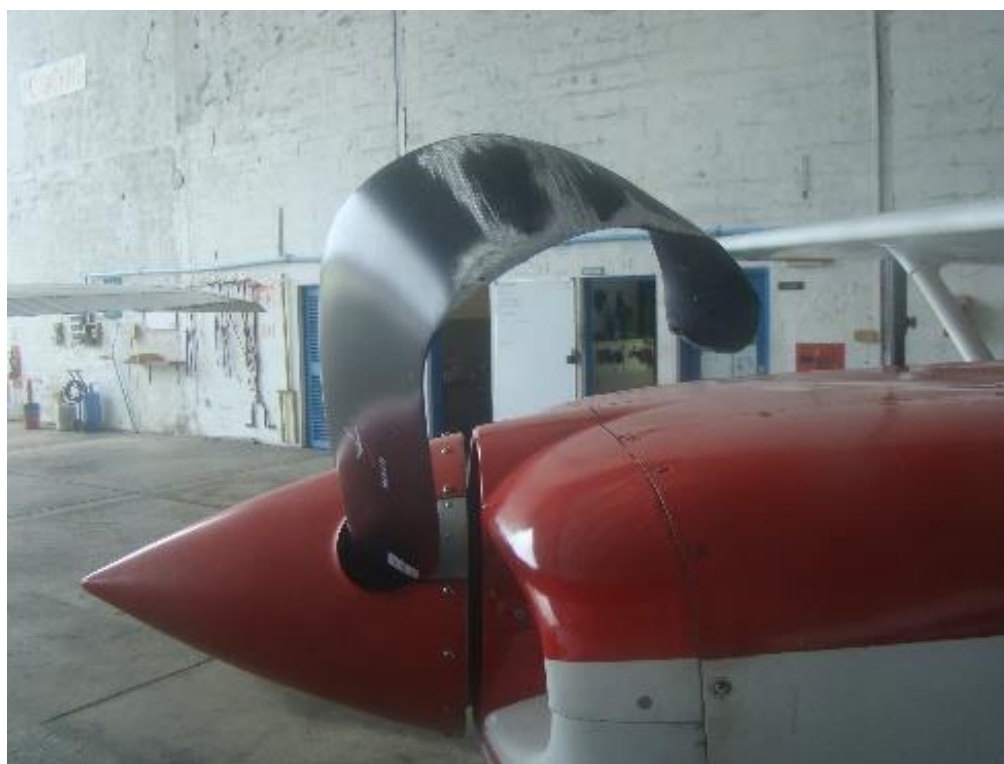
Propeller is found badly damaged after it had struck the runway; blades bent, twisted and chafed, as seen in the images in the Appendix 5.7 of this report.

Figure 3: Bent Propeller

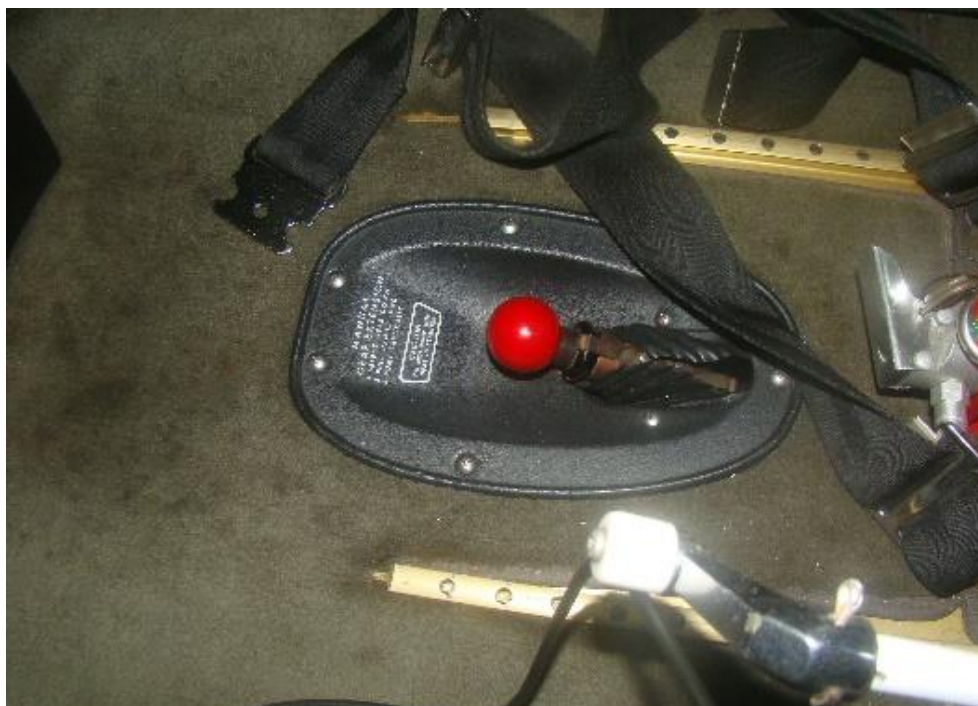
Figure 4: Manual System handle

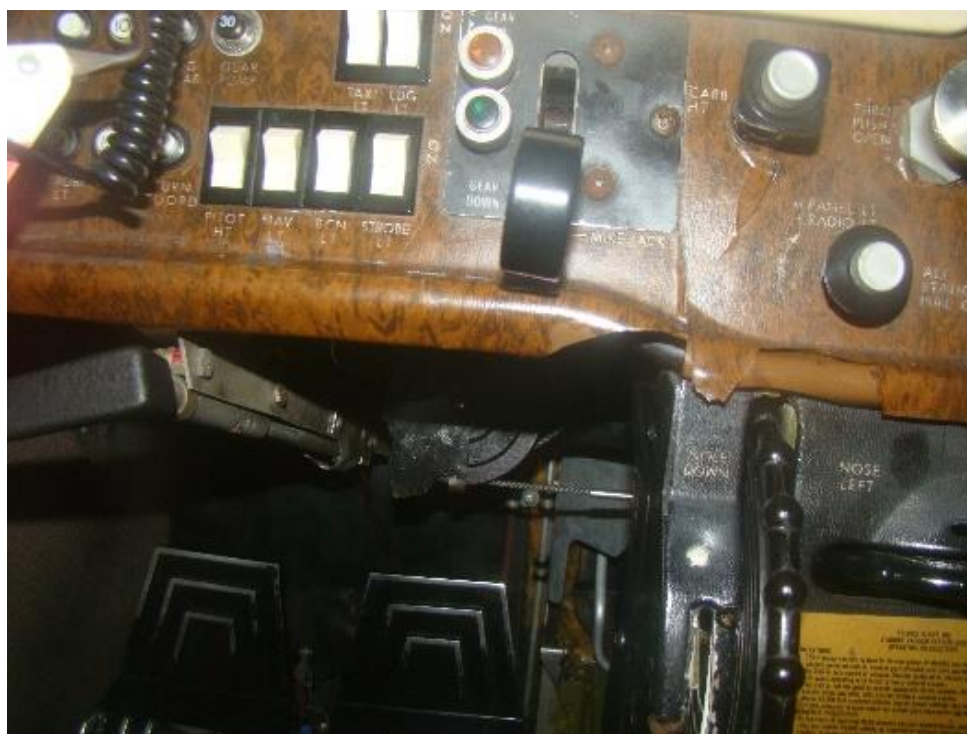
The aircraft is incorporated with a modification; installing a red indicator light replacing the UP indicator (amber) light which cautions the pilots of GEAR UNSAFE condition. The GEAR UNSAFE (red) light is ON anytime the gear is in transit (retract cycle), or whenever system pressure drops below 1000 psi with the safety (squat) switch closed.

Figure 5: landing gear selector switch and gear position indicator lights

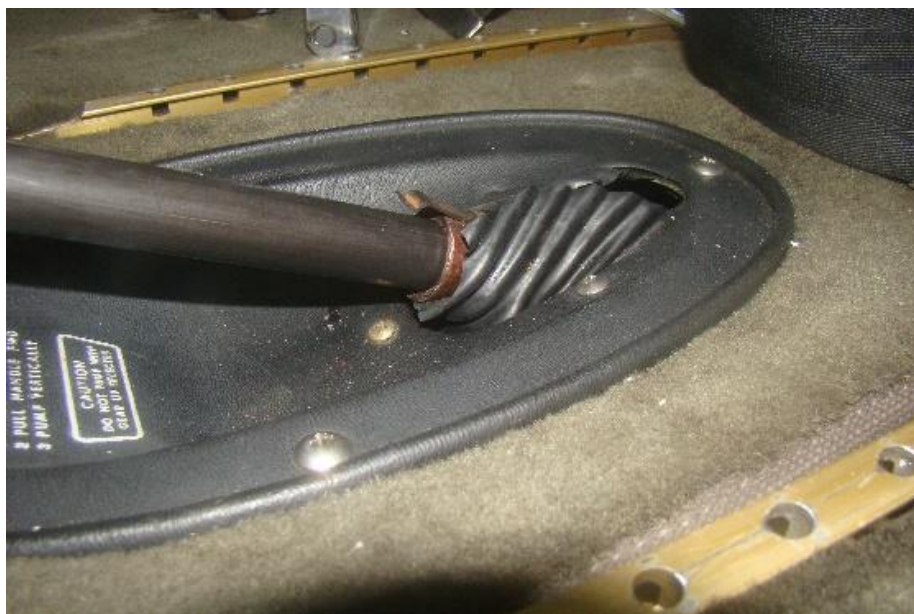
Figure 6: Handle for manual operation of Landing gear
