## **Accident Investigation Coordinating Committee**

### **Report 2018/01**

Final Report on the Serious Incident to  
Airbus, A330-300 (9M-XXC), A350-900 (A7-ALL)  
Velana International Airport, Maldives  
7 July 2018

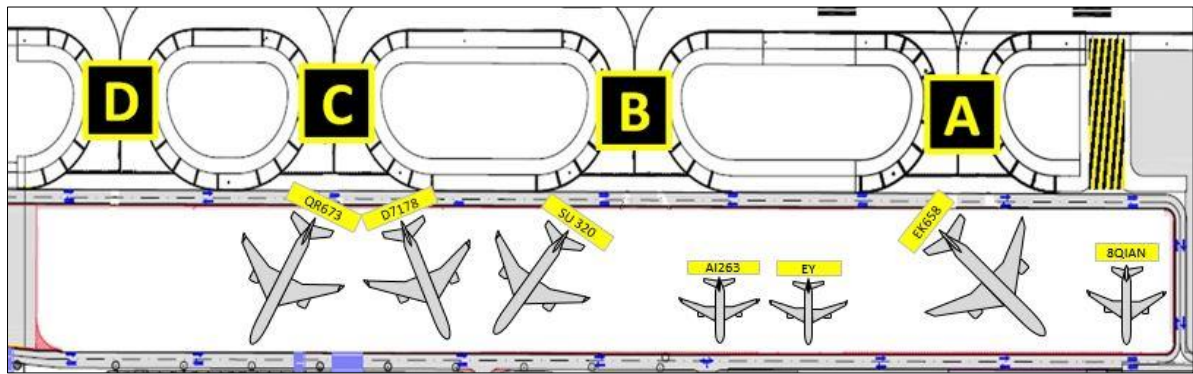
Figure 5 – Parking allocation for 9M-XXC

"Plan-4" was generated for the arrival of 9M-XXC (flight number D7178), among other aircraft. In this plan 9M-XXC was to be parked near Taxi-way C between A7-ALL (flight number QR673) and another A330 (flight number SU 320).

According to the parking plan generated for parking of AirAsia A330, it is evident that the apron was very congested. In this particular incident, only one marshaller and one wing-walker were found deployed to guide the taxiing aircraft into the allocated parking position as opposed to three required (one marshaller and two wing walkers) as per MACL Ramp Services SOP. Due to the limited available space to manoeuvre aircraft and the prevailing congestion on the apron, walking continuously with the wing of a moving aircraft was extremely difficult, though it is stated so in the MACL Ramp Services SOP.

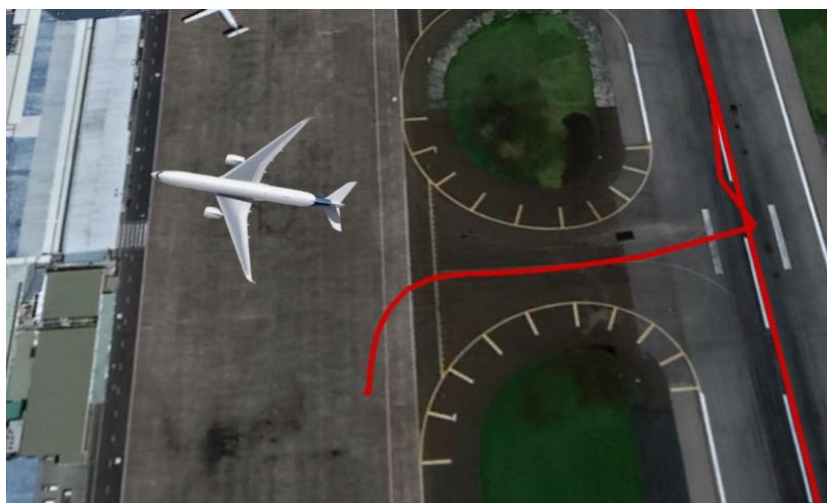
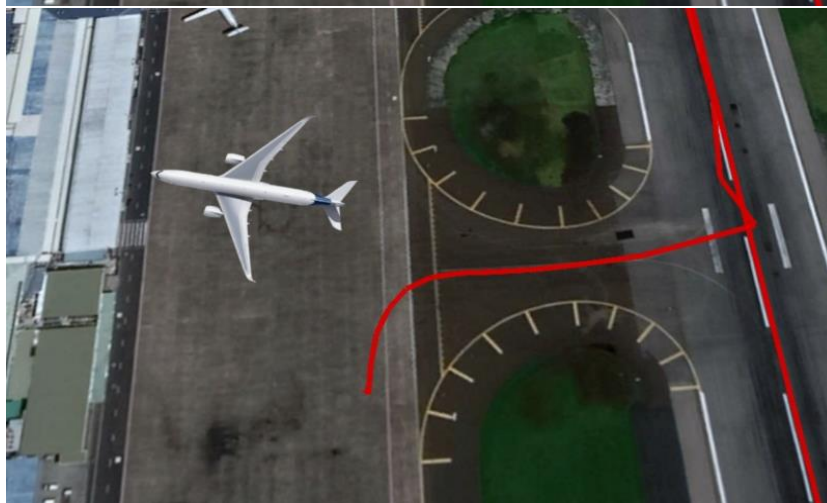
Figure 7 – The path (red line) taken Air Asia aircraft

The red line in the above figures represent the movement of the aircraft from the Flight data System. It is evident from the mapping above, the starboard (right hand) wing of the Air Asia aircraft could not have cleared the Qatar Airways aircraft horizontal stabilizer.
