## ACCIDENT INVESTIGATION COORDINATING COMMITTEE

AIRCRAFT ACCIDENT REPORT 2021/01

INVESTIGATION OF THE ACCIDENT INVOLVING  
MANTA AIR OPERATED VIKING AIR DHC-6-300 FLOATPLANE  
8Q-RAE, AT VELANA INTERNATIONAL AIRPORT  
MALDIVES

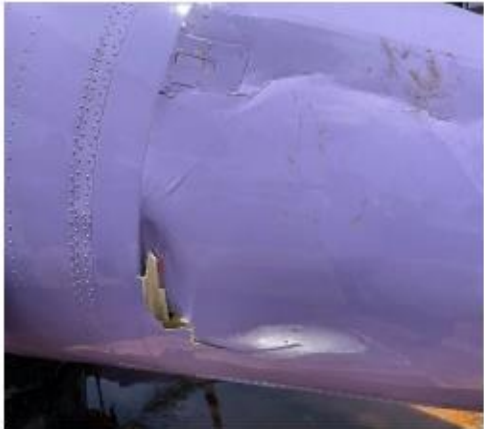
<p>3 Nose Compartment Door</p>

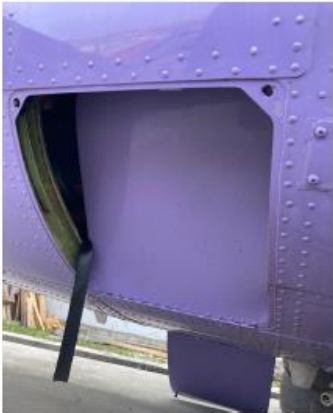
<p>4 Hydraulic bay panel</p>

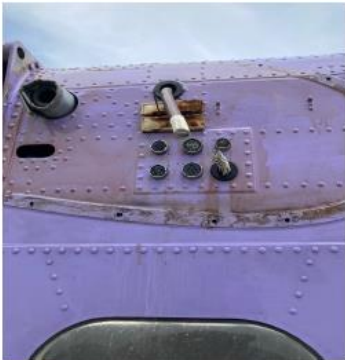
<p>1 RH wing attachment</p>

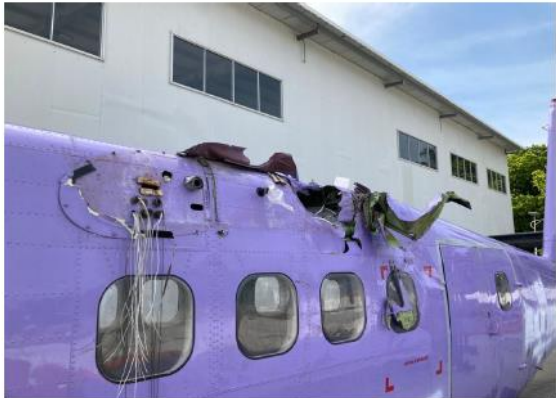
<p>5 6 LH wing attachment</p>

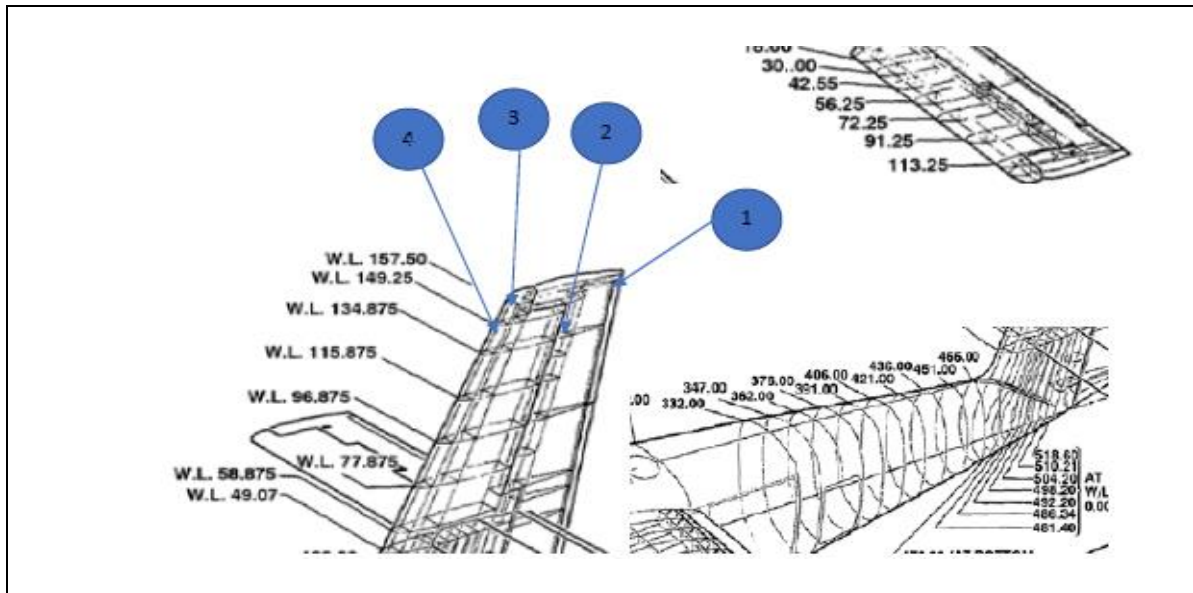
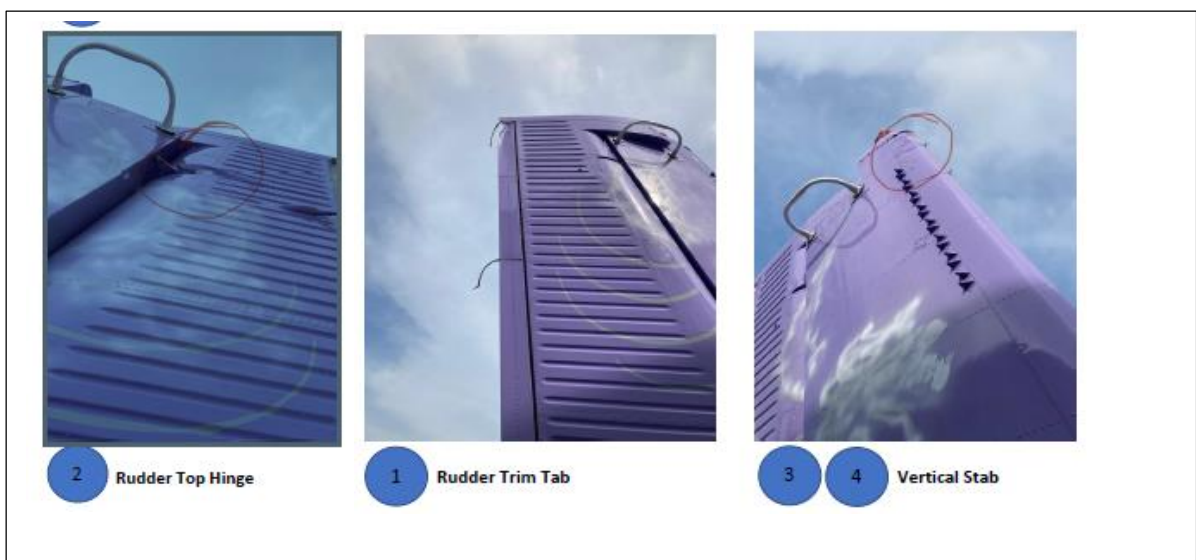
#	Inspection Details	Area	Condition and findings of the area inspected
1	Rudder Trim Tab		Heavy dent and buckled at top of the tab, damage from keeping on barge in salvage operation
2	Rudder top hinge skin		Heavy dent and buckled at top of the tab, damage from keeping on barge in salvage operation
3	Beacon light cover		Cover broken from screws
4	Vertical Stabilizer		Top end dent.

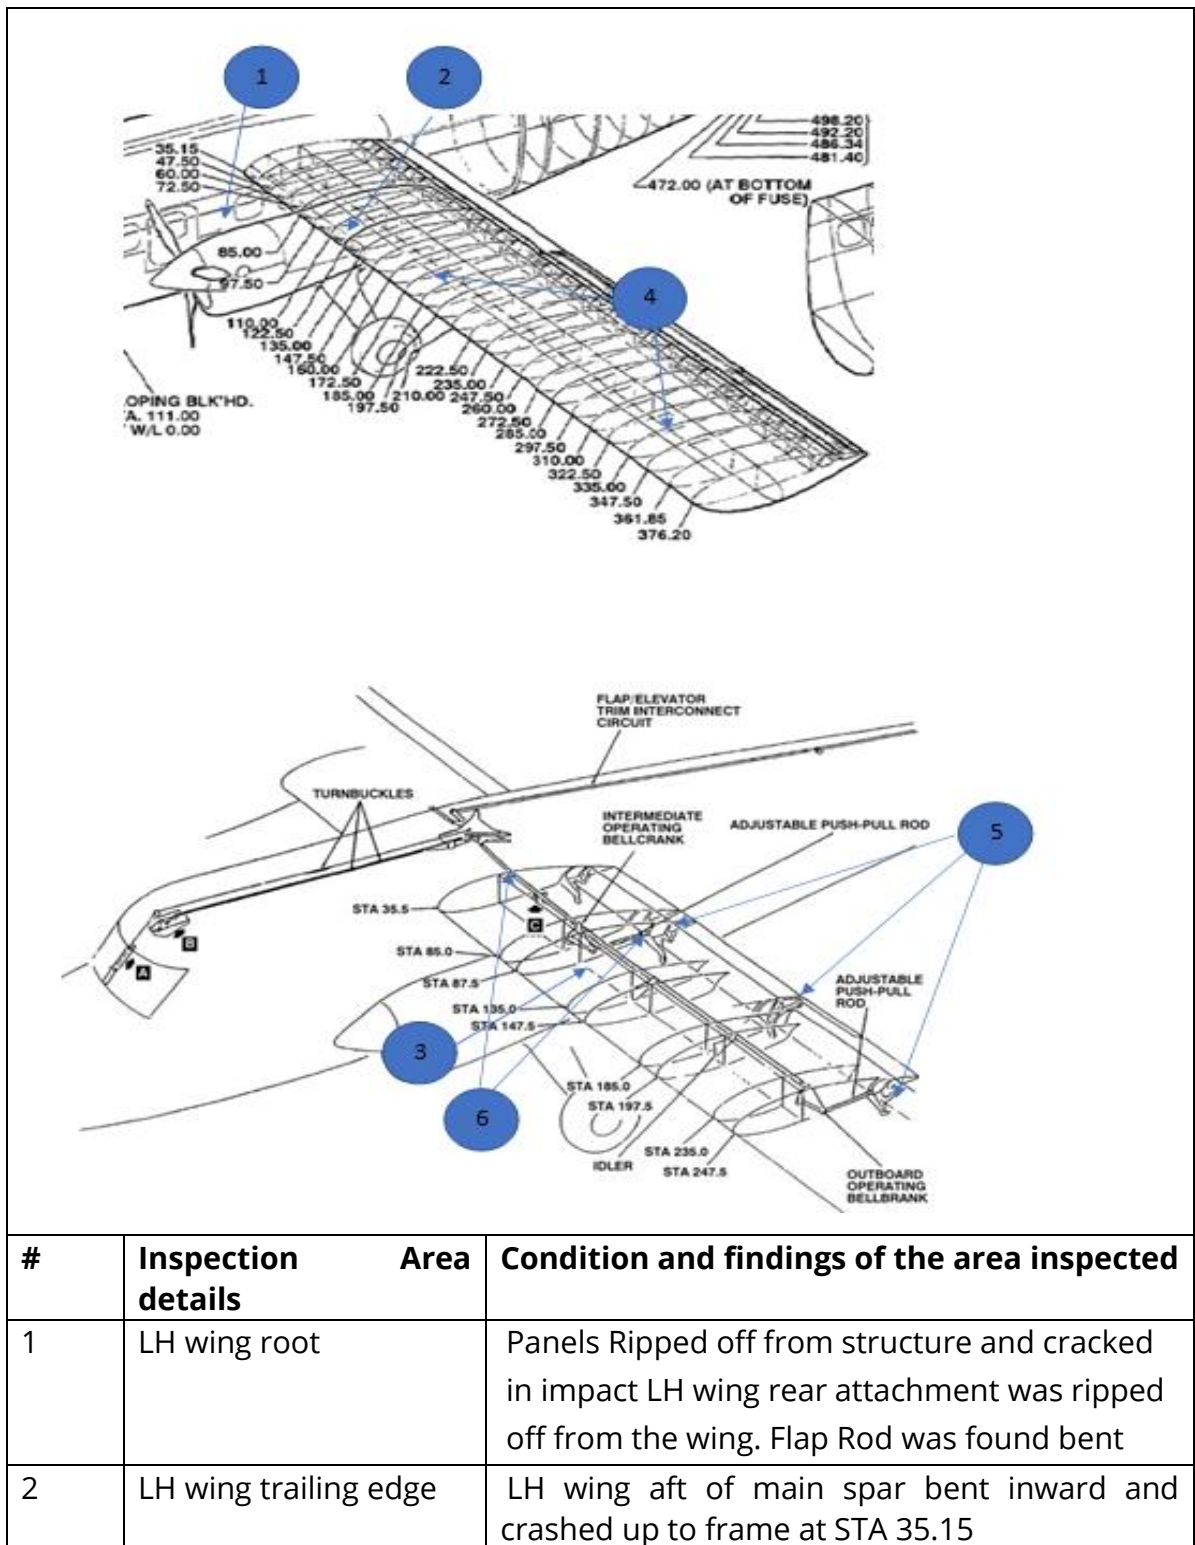
3	LH wing leading edge	LH wing outboard of STA 297.00 was crushed and wing cracked open from leading edge and top skin at STA 297.00
4	Flight Controls	Inboard fore flap and trailing flap was ripped off during impact, trailing flap structure between STA 97.5 and STA 172.5 and fore flap attachment at STA 9 was hanging from the aileron push rod. Outboard fore flap and aileron was ripped off from the wing and was not recovered in the salvage operation.
5	Wing Hinge Arms	All wing hinge arms bent, sheared and damaged in impact. Wing Hinge arm at STA 366.2 was ripped off from wing and was not recovered in the salvage operation.
6.	Flight control and flap control rods	Inboard fore flap push rod was bent outwards. Aileron push rod found sheared off near the Belk crank. Outboard fore flap pushrod bent and sheared off near the wing cut out.

<p>2 LH Wing Inboard trailing edge</p>	  <p>2 5 LH Wing trailing edge, shroud skin And Hinge arms.</p>
  <p>3 LH Wing outboard</p>	  <p>3 LH Wing outboard</p>
  <p>1 6 LH Wing outboard and Flap push rod</p>	  <p>3 LH Wing root</p>

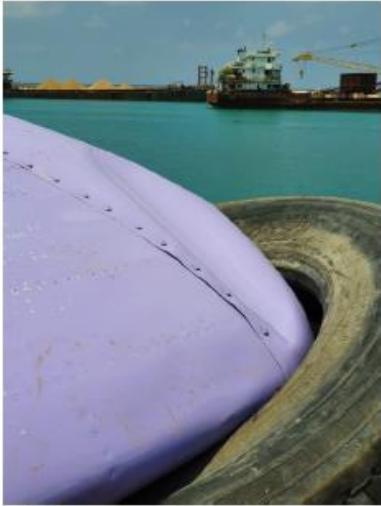
1 RH Wing Tip

#	Inspection Area details	Condition and findings of the area inspected
1	Outboard panel	Outboard panel found dented and damaged

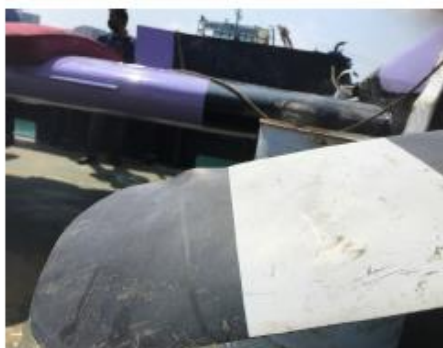
#	Inspection Area details	Condition and findings of the area inspected
1	Engine propeller for free movement	Engine found seized
2	Propeller	One blade has a dent in the trailing edge towards the tip. All blades found bent and twisted extensively and has impact damage marks the blade leading edge
3	LH engine fuel shutoff rod	Found sheared off near the attachment to the bell crank.
4	Pulley bracket	Found ripped off from the nacelle structure
5	Engine exhaust case	Found dented and cracked open
6	Longeron	Outboard longeron found cracked
7	Engine for corrosion	Engine and components severely corroded due to exposure to salt water.

2 Dent on LH Propeller

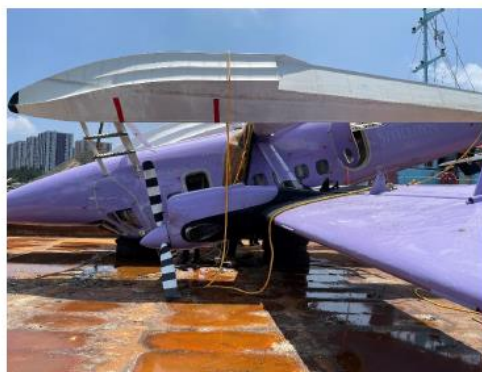
1 RH Engine and Propeller

#	Inspection Area details	Condition and findings of the area inspected
1	Engine propeller for free movement and corrosion	Engine found seized. Engine and components severely corroded due to exposure to salt water. RH propeller found with no bents or impact marks

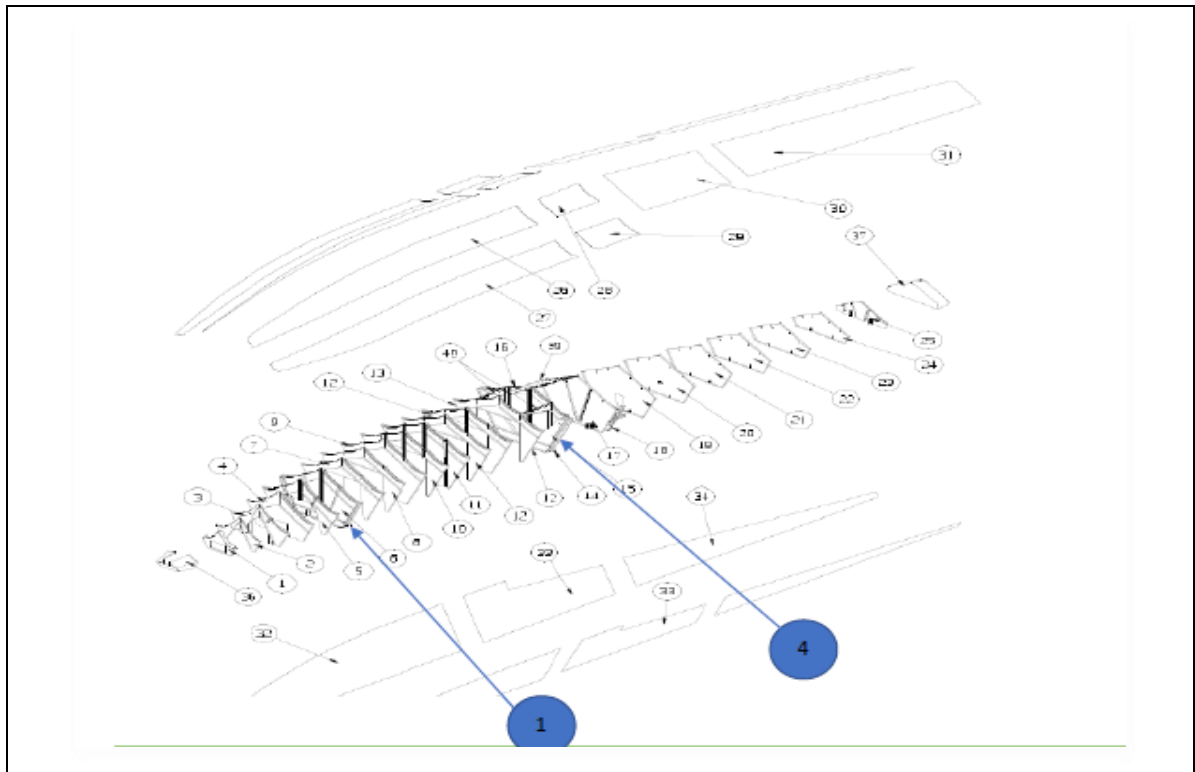
#	Inspection Area details	Condition and findings of the area inspected
1	LH float forward strut	Strut ripped off from lower attachment fitting to floats Gunwall near forward strut dented Inboard skin near forward strut punctured
2.	Spreader Bars (not shown in fig)	Forwards spreader bar cracked, bent and sheared from near LH float attachment. Aft spreader Bar sheared, bent and cracked from near LH float attachment
3	V strut (not shown in fig)	LH V strut ripped off from lower attachment fitting RH V strut ripped off from top attachment fitting
4.	LH Pylon and float	Pylon forward attachment and attachment fitting ripped off from float and ruptured top skin. Skin between pylon forward attachment and bulkhead cracked open Pylon lower skin dented and one hole punctured with few rivets sheared Pylon forward attachment cracked.

Inboard and outboard near pylon bent with skin LH float lower skin towards pylon found dented
5	RH float pylon (not shown in fig)	Top skin found dented.
<div><div> <p>4 LH Pylon and float</p></div><div> <p>4 LH Pylon and float</p></div><div> <p>4 LH pylon Forward attachment</p></div></div>		
<div><div> <p>4 LH Pylon and float</p></div><div> <p>1 LH float forward strut</p></div><div><div> <p>2 3 Aft spreader bar and V strut</p></div></div></div>

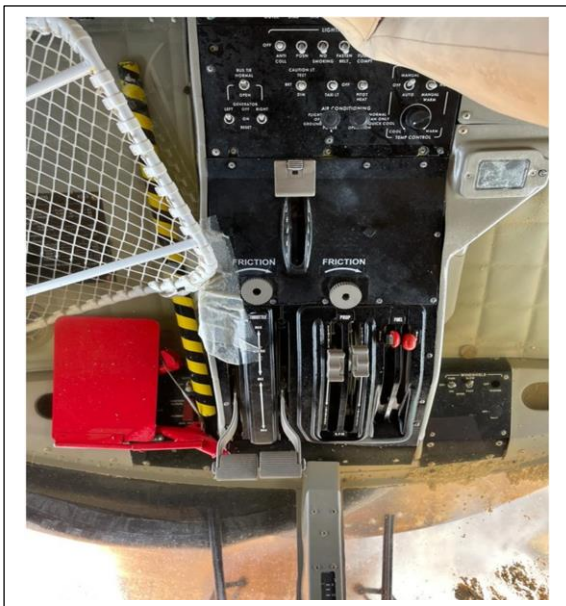
As evidenced from the following image, captured from the cockpit of the aircraft whilst in an inverted position showed the flap selector lever being at zero position (fully retracted) :

The image also showed power levers in MAX position while the propeller levers in minimum cruise position. From the results of the investigation carried out on the wreckage it can be concluded that full flaps were in fact selected to fully extended position during landing, as opposed to the retracted position of the flaps lever indicated above.

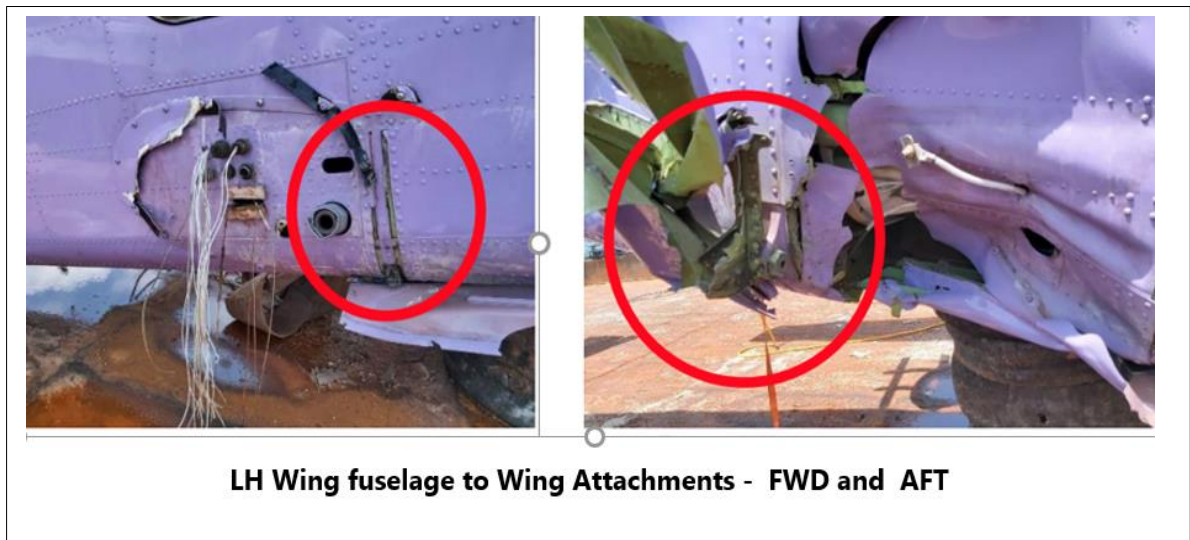
Examination of the aircraft wreckage whilst it was still underwater confirmed that the left-hand wing of the aircraft had detached completely. The divers who were carrying out wreckage salvation were unable to locate the left-hand wing for quite some time into the salvage process. To clear the water runway (NR) for inbound and outbound traffic the wreckage (less left-hand wing, left-hand engines and propellers) was removed from where it crashed and lying submerged in an inverted position.

Of the four attachment points, three were found failed (sheared off) as seen from the images above. They include:

- Left-hand wing strut assembly lower end fitting;
- Left-hand wing assembly forward fuselage to wing attachment point;
- Left-hand wing assembly aft fuselage to wing attachment point.
