ACCIDENT INVESTIGATION COORDINATING COMMITTEE

AIRCRAFT ACCIDENT REPORT 2017/02

**PRELIMINARY REPORT ON INVESTIGATION OF THE
ACCIDENT OCCURRED ON VIKING AIR DHC-6-300,
8Q-ISB AIRCRAFT AT VELANA INTERNATIONAL
AIRPORT, MALDIVES**

on 4th October 2017

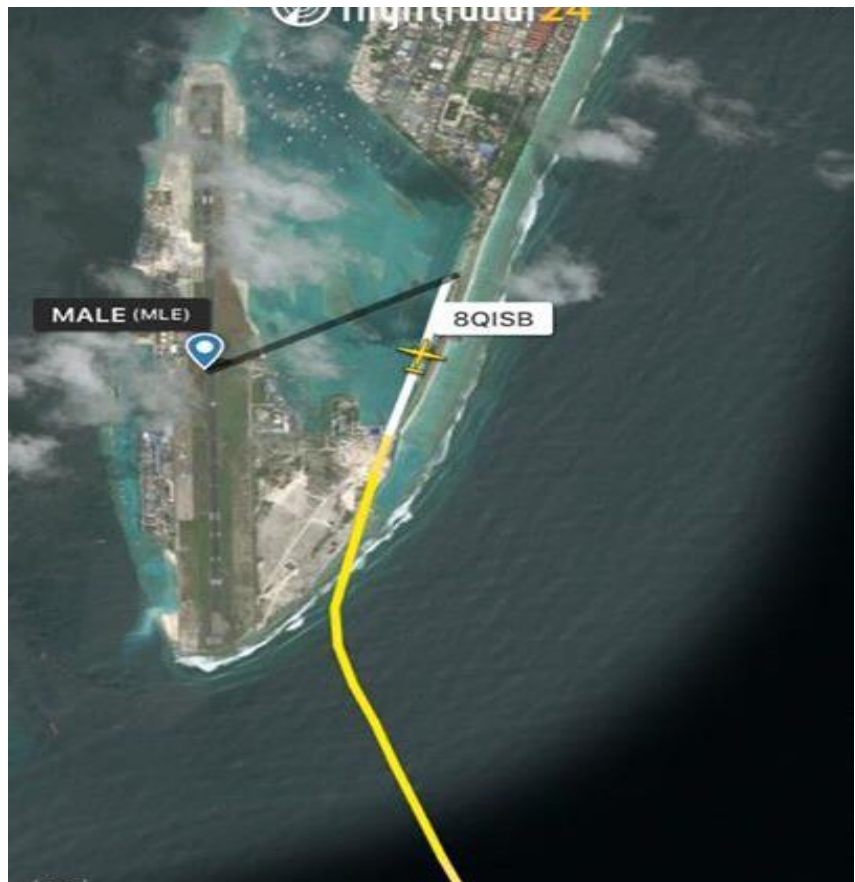
Figure 1: 8Q-ISB aircraft final approach path to RWY NR

The aircraft touched down in the intended landing area (Figure 1), on the left float first and bounced, then contacted the water a second time on the right float. The co-pilot reduced power by pulling the power levers back. At the same time, as stated by the Captain, he placed his right hand on the power levers (over the co-pilot's left hand) and pushed the power levers fully forward, applying full power with the intention of going around whilst calling "Max

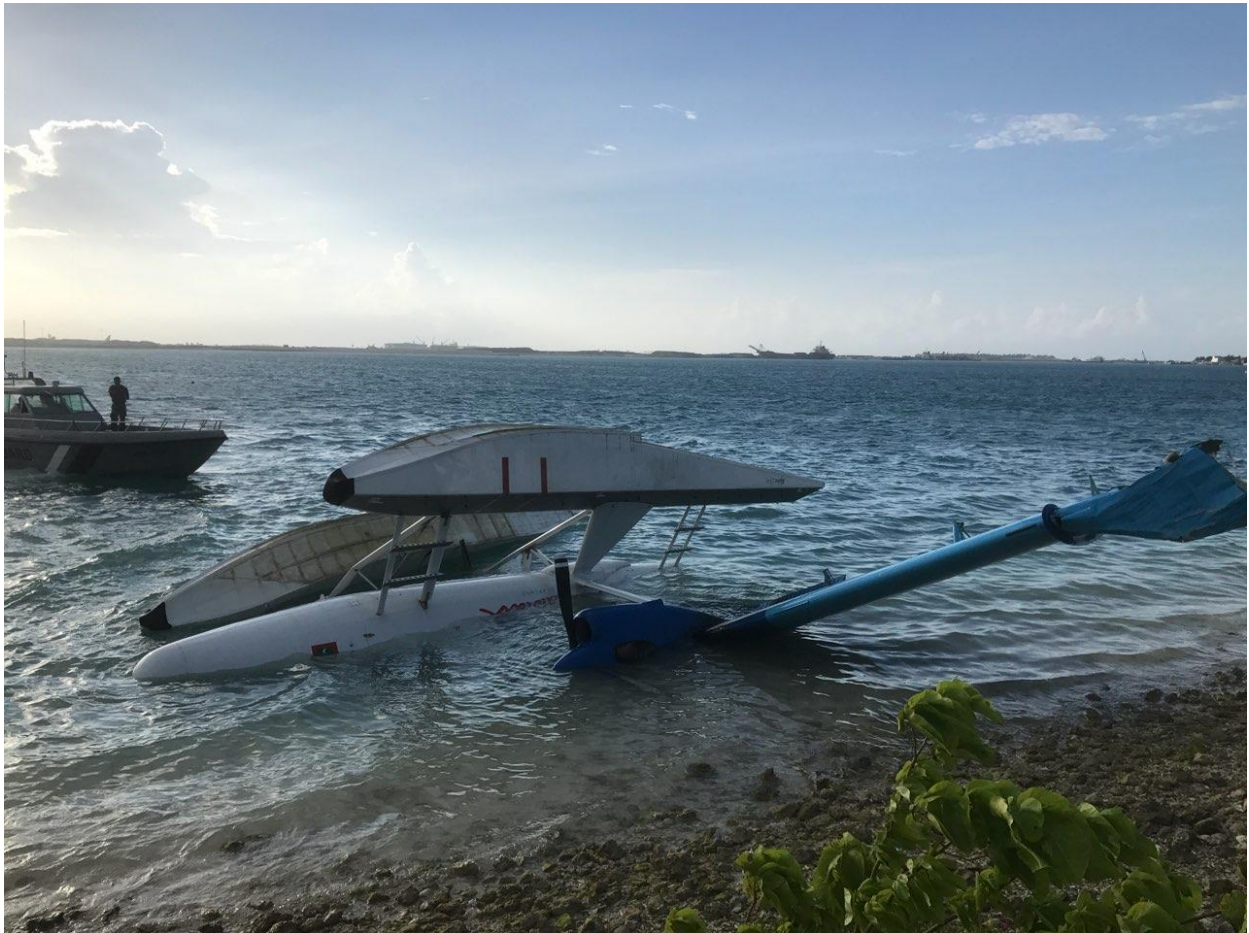
The aircraft banked sharply to the right, turning right and crashed. The aircraft finally flipped over and halted upside down facing South and was partly submerged. (Figure 2).

Figure 2: The aircraft wreckage
