AIRCRAFT ACCIDENT REPORT P2020/03

PRELIMINARY REPORT

**ON INVESTIGATION OF THE ACCIDENT INVOLVING VIKING AIR
DHC-6-300, 8Q-TMF AIRCRAFT
AT VELANA INTERNATIONAL AIRPORT WATER AERODROME, MALDIVES
on 05 October 2020**

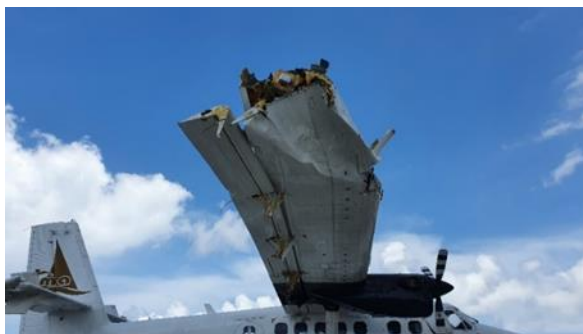
Figure1: RH Wing

1. Right Hand Wing:
 - a. Various damages in the area between ribs 25 to 28
 - b. The leading-edge bottom skin towards the wingtip buckled upwards
 - c. Wing tip severely crushed and material missing
 - d. Wing fin dislocated with the leading edge shifted outboard
 - e. The inboard trailing flap skin buckled upward
2. Left Hand Wing:
 - a. Leading edge bottom skin buckled upwards
3. Left Hand Propeller:
 - a. LH propeller blades (all three of them) bent aft
 - b. LH propeller assembly dislocated
4. Airframe:

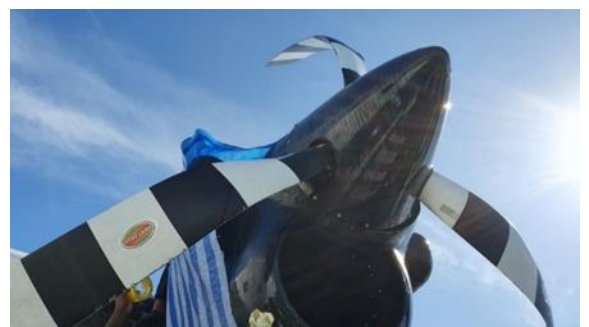
Immediately after the "U turn" the left wing abruptly dropped which resulted in the left wing and LH engine propeller blades impact the water heavily causing damage to the wing and the propeller blades.

Figure 2: LH Propeller
