SAFETY INVESTIGATION REPORT 2023/01/P

PRELIMINARY REPORT

**INVESTIGATION OF THE ACCIDENT AT VOMMULI WATER AERODROME
INVOLVING VIKING AIR DHC-6-300 AIRCRAFT, 8Q-TAQ OPERATED BY
TRANS MALDIVIAN AIRWAYS (TMA)**

16 May 2023

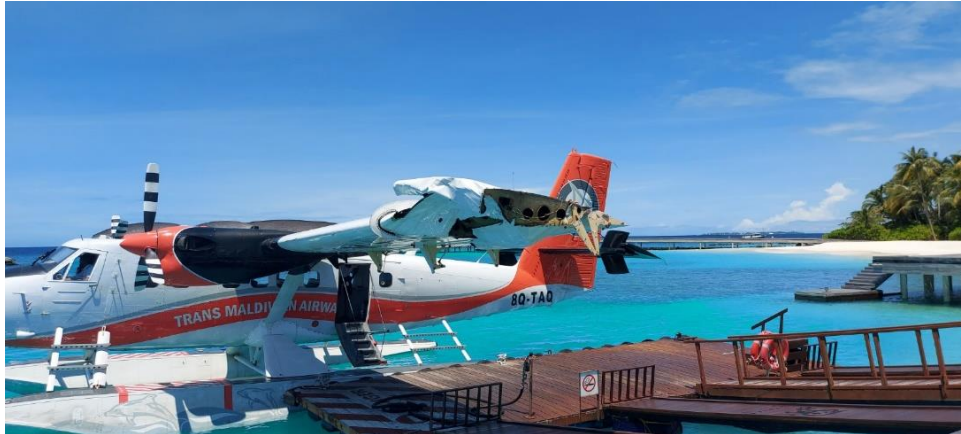
Figure 1 LH Wing Damage

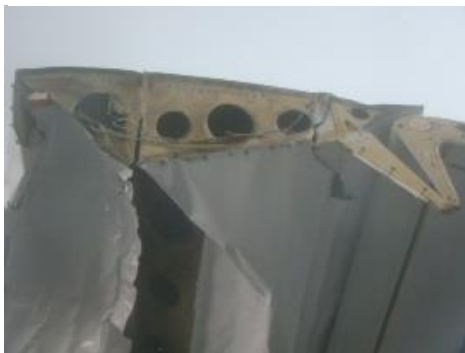
Figure 3 LH Wing (RIB NO. 28) Damage

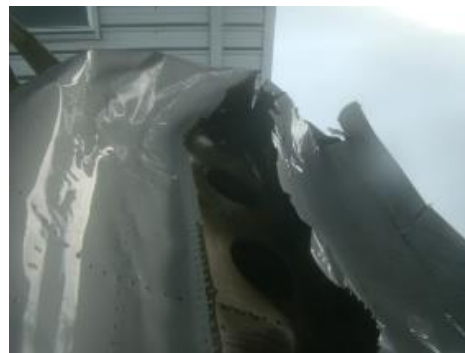
Figure 2 LH Wing Damage

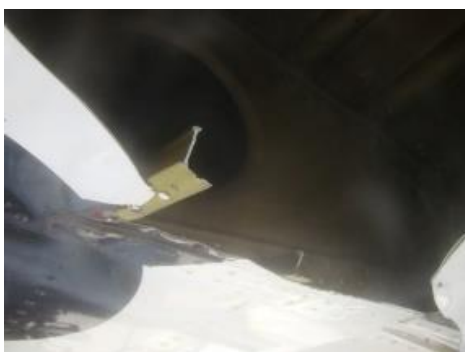
Figure 4 LH Wing Damage

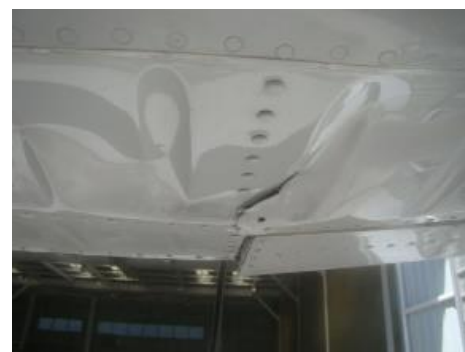
Figure 5 LH Aileron Damage

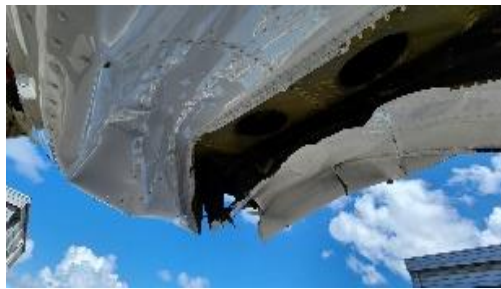
Figure 6 LH Wing Leading Edge Damage

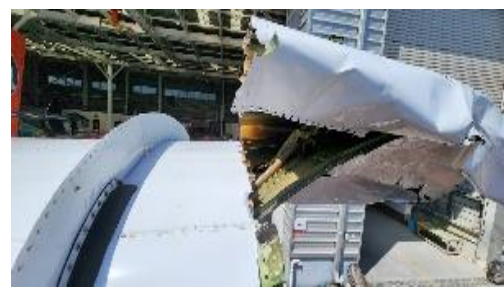
Figure 6 LH Wing Top Damage

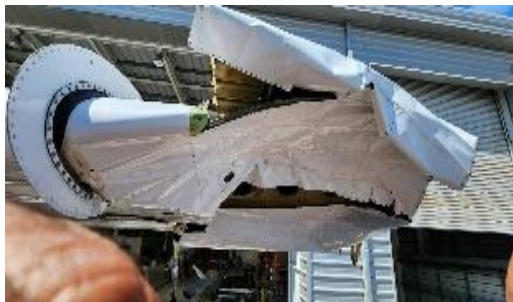
Figure 8 LH Wing Leading Edge Damage
