ACCIDENT INVESTIGATION COORDINATING COMMITTEE

**ACCIDENT REPORT ON
8Q-TMK (TWIN OTTER)
At the Ibrahim Nasir International Airport, Water Runway,
Maldives
On 2nd August 2013**

Operator: Trans Maldivian Airways
Manufacturer: Viking Air (Canadian)
Model: DHC-6-300 (Floatplane)

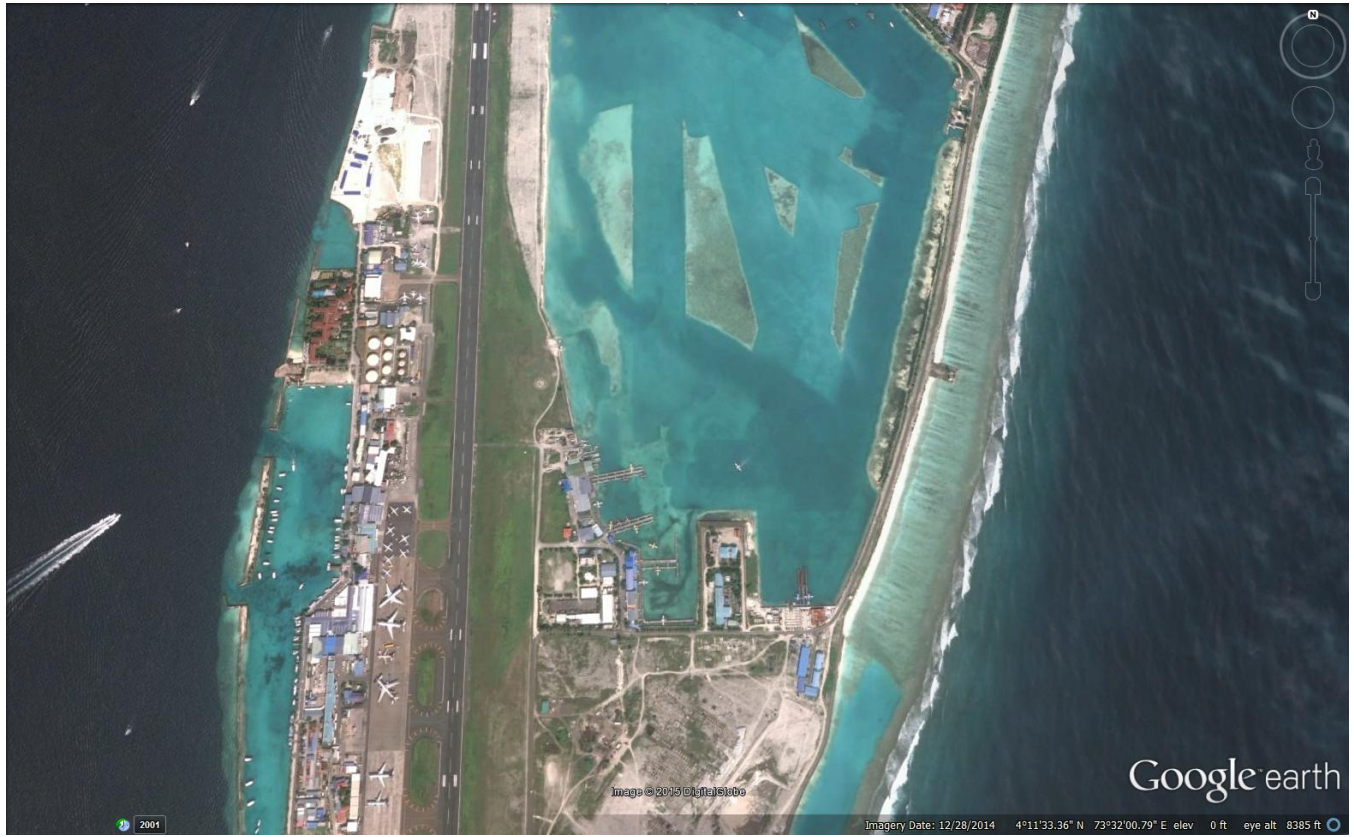
Appendix 3

At the time of the accident the aircraft landed on the west bound water runway (Appendix 3). The runway was clear and the runway conditions were normal – no known runway condition that contributed to the accident.

Water Aerodrome, Ibrahim Nasir International Airport
