**AIRCRAFT SERIOUS INCIDENT REPORT 2020/04**

**FINAL REPORT**

**INVESTIGATION OF THE SERIOUS INCIDENT INVOLVING  
TRANS MALDIVIAN AIRWAYS OPERATED  
VIKING AIR DHC-6-300, 8Q-TMR, FLOATPLANE  
AT SUN SIYAM IRUFUSHI RESORT WATER AERODROME, MALDIVES**

**22 October 2020**

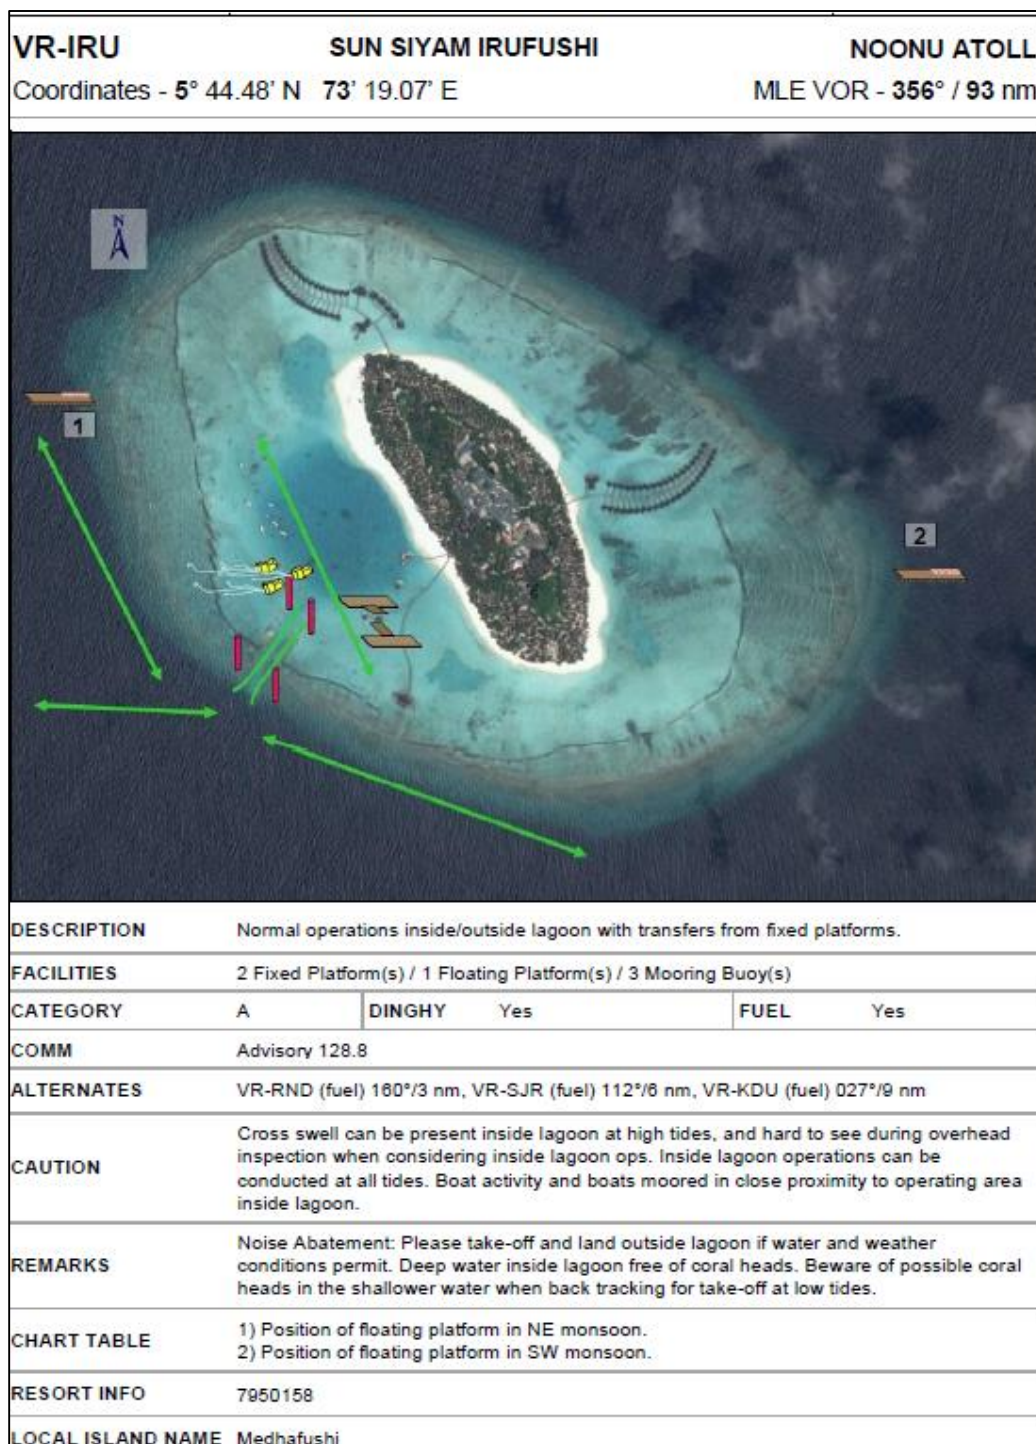
Figure 1: Sun Siyam IruFushi Resort Water Aerodrome Chart

Location of the water aerodrome, including 4 proposed areas and lines of landing, at Sun Siyam IruFushi Resort is shown on the aerodrome chart, issue 4, revision 0, published by TMA, dated 10 June 2018.

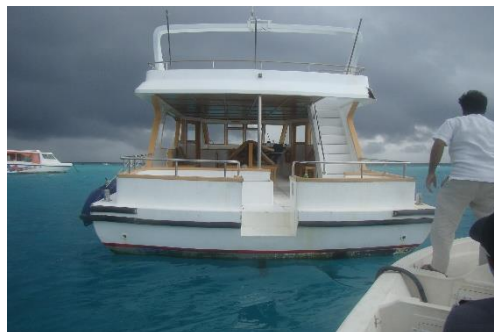
The below photos show the damages to both the aircraft and the vessel caused due to the accident.

Figure 10: The vessel with which the aircraft collided
