## **Accident Investigation Coordinating Committee**

### **Report 2018/01**

Final Report on the Serious Incident to  
Airbus, A330-300 (9M-XXC), A350-900 (A7-ALL)  
Velana International Airport, Maldives  
7 July 2018

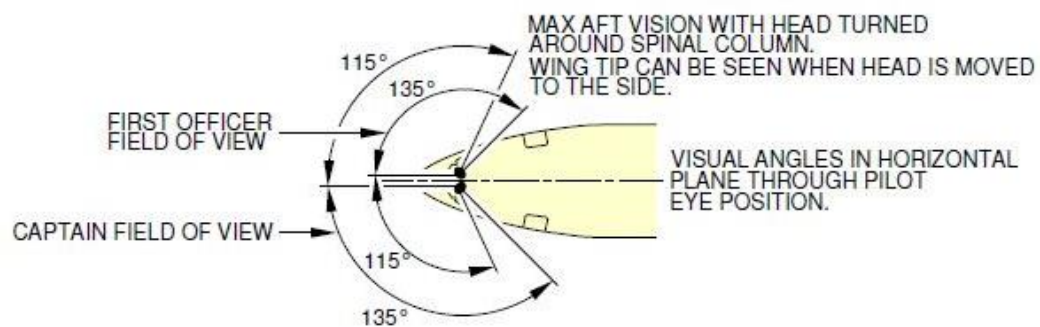
Figure 1 – A330-300 visibility from cockpit in static position

On the A330-300 aircraft, the visual angle in the horizontal plane through the co-pilot's normal eye position and looking towards the wingtip is  $115^\circ$ . If the pilot moves his head to the side, the visual angle in the horizontal plane increases to  $135^\circ$ , and the wing tip becomes visible, as summarised in Figure 1.

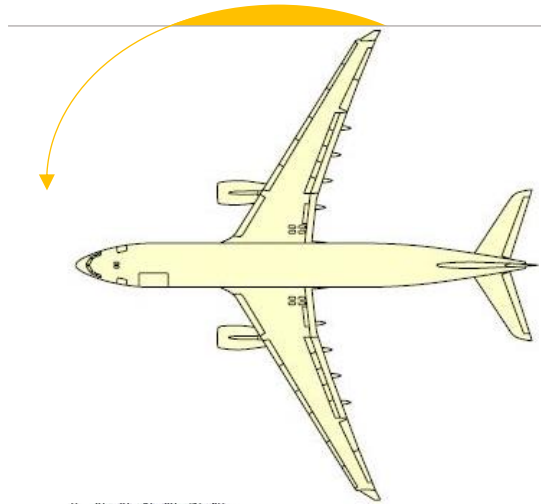
Figure 3 – Swept wing growth

The A330 aircraft, like most modern large transport aircraft have swept wings that are subject to a phenomenon known as 'swept wing growth' or 'wing creep'. This occurs during a turn when the wing tip describes an arc greater than the normal wingspan due to the geometry of the aircraft and the arrangement of the landing gear<sup>1</sup>.

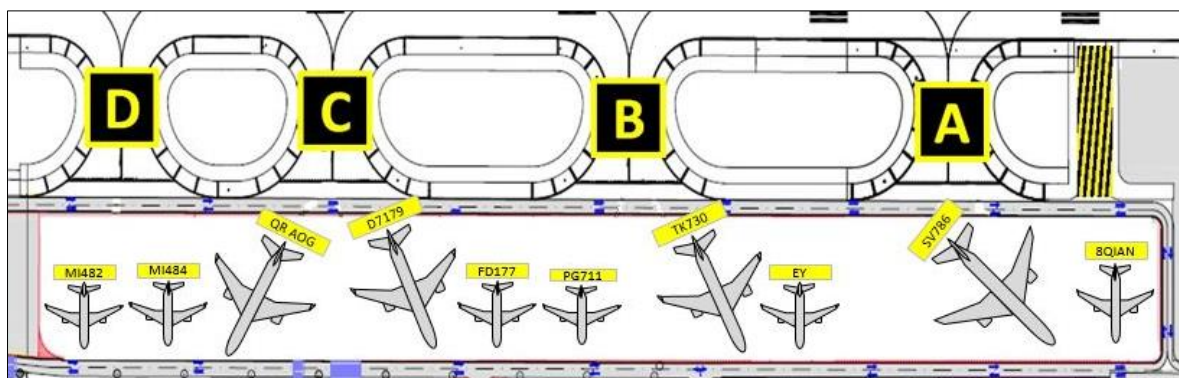
Figure 6 – Parking Allocation with the most aircraft

The Duty In-charge is responsible to brief the marshaller on where and how the aircraft should be parked based on this allocation scheme. At the same time, the SOP states 'parking is carried out solely based on the experience of the marshaller' as the apron is not marked.

Given that the parking bays are not marked, the allocation (i.e. number, type and orientation) of aircraft varies depending on the traffic. For example, the parking allocation with the most number of aircraft, for the day, was "Plan-6" shown in figure 6. In this arrangement 10 aircraft are parked.
