## ACCIDENT INVESTIGATION COORDINATING COMMITTEE

AIRCRAFT ACCIDENT REPORT 2021/01

INVESTIGATION OF THE ACCIDENT INVOLVING  
MANTA AIR OPERATED VIKING AIR DHC-6-300 FLOATPLANE  
8Q-RAE, AT VELANA INTERNATIONAL AIRPORT  
MALDIVES

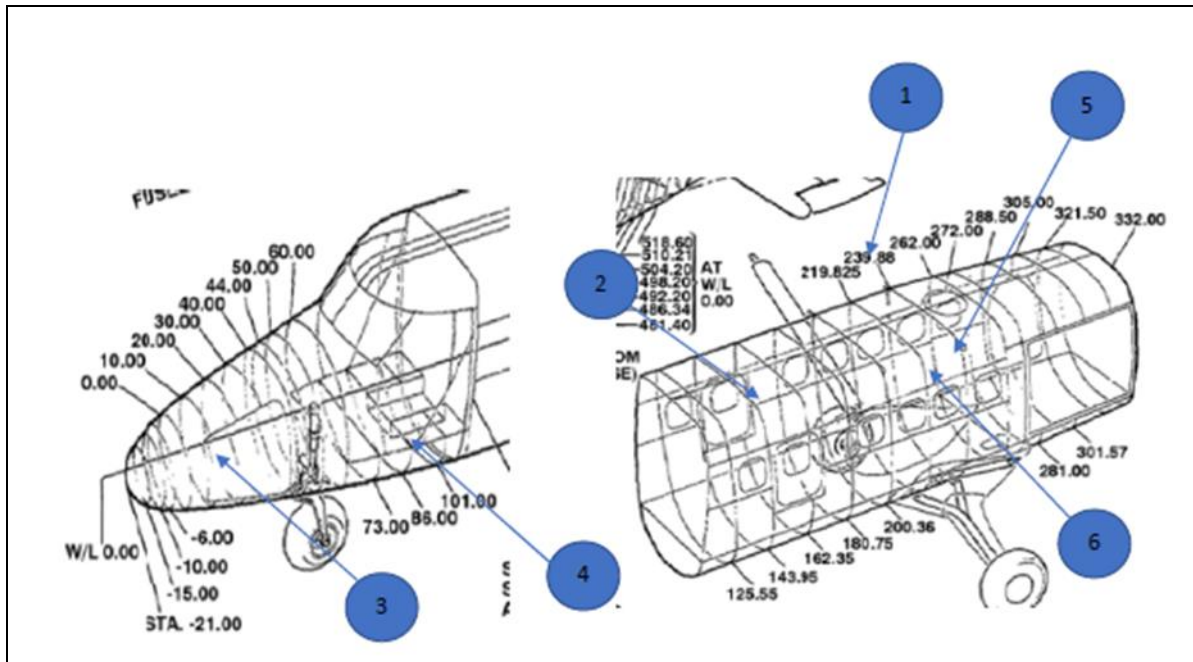
#### Fuselage – Exterior:

#	Inspection Details	Area	Condition and findings of the area inspected
1	RH wing attachments		N/A
2	RH emergency exit		Lost in accident
3	Nose compartment door		Door was open on impact and is cracked and buckled inwards
4	LH hydraulic Panel		Panel buckled inwards
5	LH wing Attachments		LH wing ripped off from the wing attachment on impact, heavily damaged refer picture
6	LH fuselage skin		Airframe LH side skin above window number five between STA 219.825 and STA 239.88 was severely buckled inwards and cracked open. LH side, above window a hole of dimension 1-2 inches was punctured on the skin.

LH airframe skin above window six between STA 239.88 and STA 272.00 is buckled inwards.
--	--	---

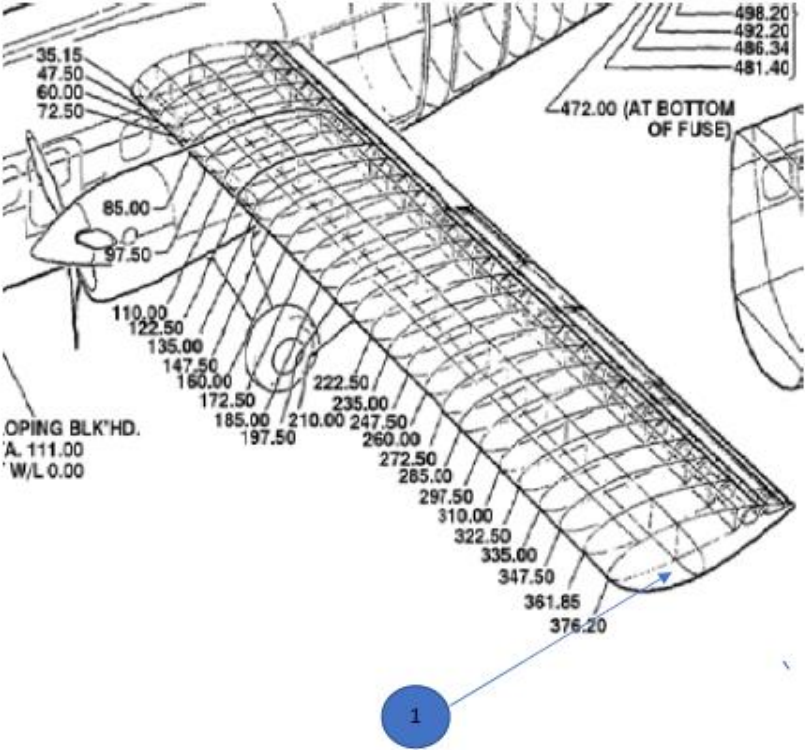
Wing Assembly – Right Hand:

#	Inspection Area details	Condition and findings of the area inspected
1	Outboard panel	Outboard panel found dented and damaged

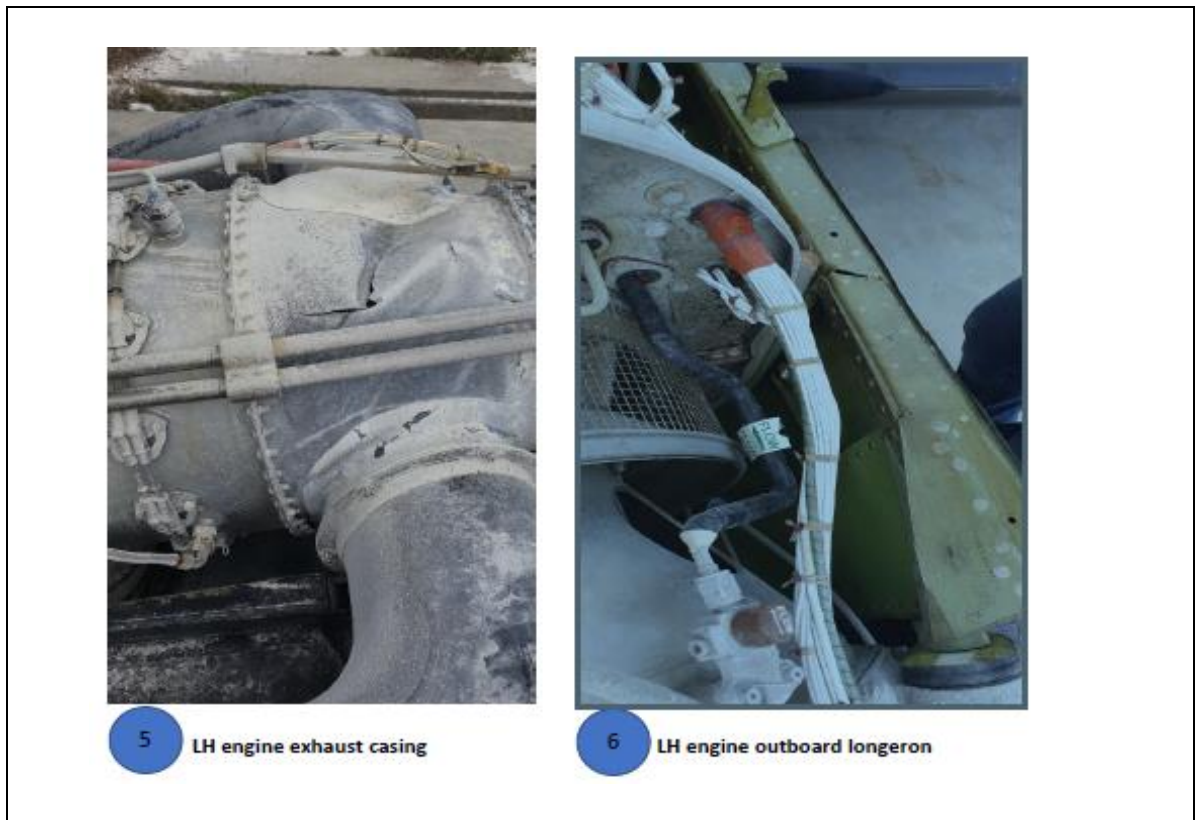
2 LH Propeller

#	Inspection Area details	Condition and findings of the area inspected
1	Engine propeller for free movement	Engine found seized
2	Propeller	One blade has a dent in the trailing edge towards the tip. All blades found bent and twisted extensively and has impact damage marks the blade leading edge
3	LH engine fuel shutoff rod	Found sheared off near the attachment to the bell crank.
4	Pulley bracket	Found ripped off from the nacelle structure
5	Engine exhaust case	Found dented and cracked open
6	Longeron	Outboard longeron found cracked
7	Engine for corrosion	Engine and components severely corroded due to exposure to salt water.

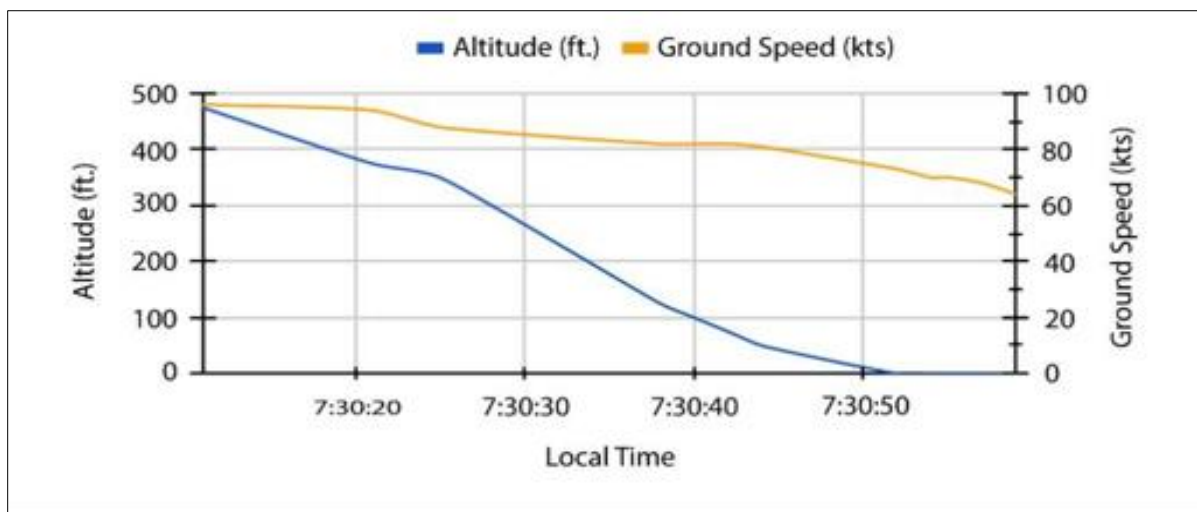
The graph below depicts the altitude and ground speed of the aircraft from 500 and 0 feet above ground. This too indicate that the target speed was maintained at touch down.

**Considering the analysis above and based on the data gathered (crew statements, CCTV footage and flight radar) it can be deduced that the aircraft on short final and at touchdown had maintained the configuration and speed stipulated in the OM.**

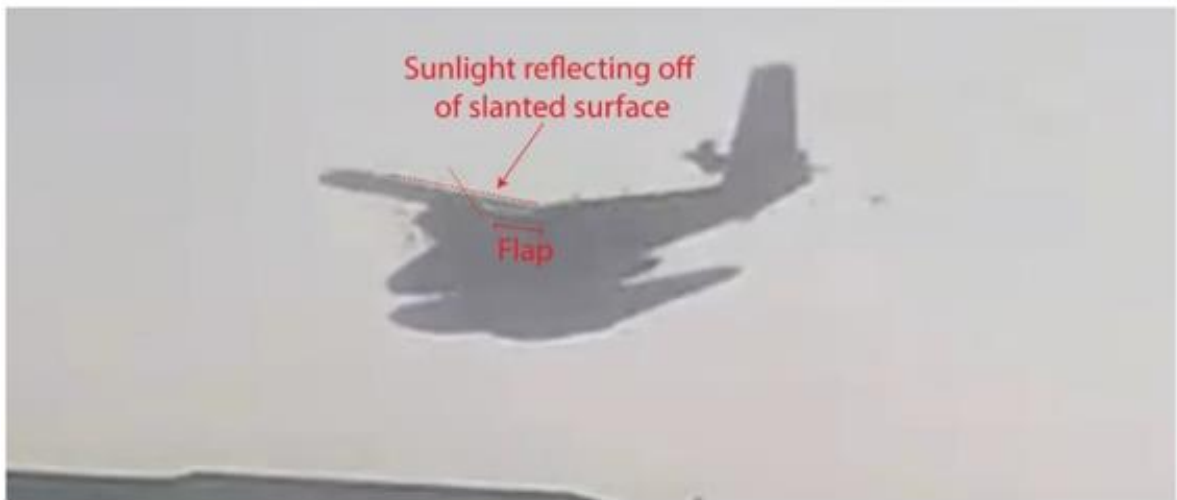
Enhanced CCTV footages of the aircraft whilst it was on approach and the images of the flap lever located in the cockpit captured whilst it was still submerged in an inverted orientation contradicts the actual position of the flaps of the aircraft at touch down. The CCTV footage showed the flaps in a down (extended) position.
